APPLICATION OF THE ELECTRICAL IMPEDANCE SPECTROMETRY METHOD FOR MONITORING FILTRATION PHENOMENA ON THE EXAMPLE OF KAROLINKA EARTH DAM

The paper presents the results of monitoring electrical properties of the soil of the body of the earth-fill dam of the Karolinka water reservoir in the fourth year after its reconstruction ended. Monitoring was carried out using the Z-meter device applying the electric impedance spectrometry method with the focus on seepage through the earth-fill dam of the water reservoir. Information about the changes that occurred in the dam body before and after the implementation of the measure (the construction of a cut-off wall when the dam was reconstructed in 2013) was obtained by monitoring the changes of the electrical resistances of the soil of the dam with time.

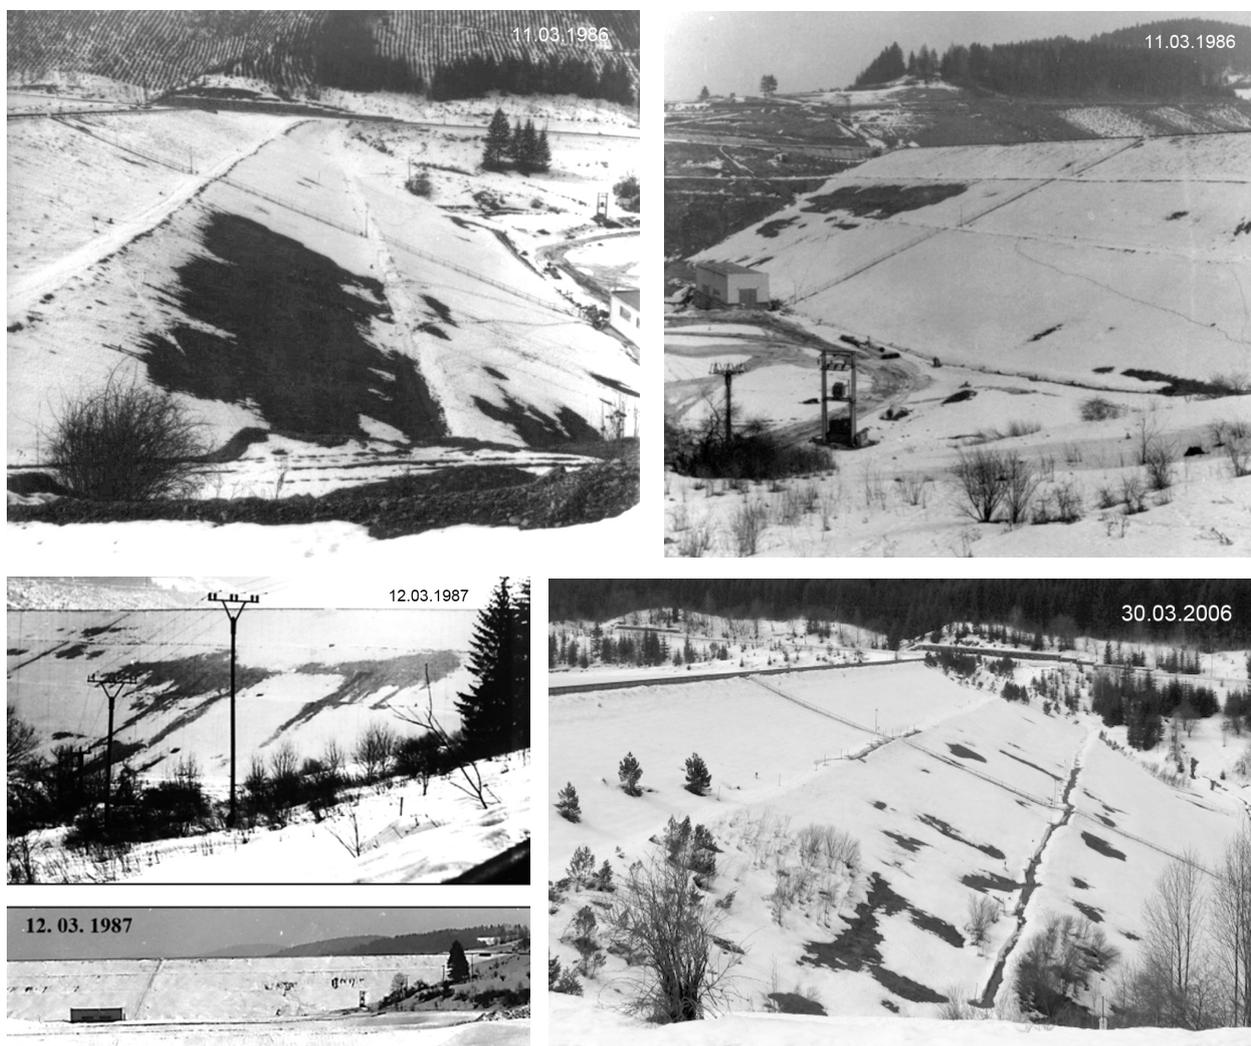
Since the fill-up of the water reservoir in February 1986, when the water in the reservoir reached a level of 517.61 m a.s.l., i.e. 2.39 m below the edge of the emergency spillway, inrushes of water have occurred on the downstream face, with a different intensity of seepage. Investigations proved that seepage was caused by the insufficient permeability of Hrozenkov gravel sand forming a zone in the downstream face of the dam and by technological indiscipline while filling the individual layers. The layers of the stabilization zone of the downstream face were filled using very heterogeneous materials that differ particularly by the content of silt particles, which should have been less than 4% according to the project, but in reality the content of silt particles reached up to 11%

(Jareš and Krejčí 2015). The seeping water flowed from certain layers of the face zone onto the downstream face of the dam where wetted places occurred (see: Fig. 3). After seepage was discovered on the downstream face of the dam, work was commenced, focused on the clarification of the origin of the seepage water and dealing with its effect on the safety of the VD. In addition, it included proposals and provided remediation of the VD (Woznica 1993, 1998, Bláha et al. 2003, Rupp 2011, Hájek 2011, Macík 2011, Rupp and Pazdírek 2012, Jareš and Krejčí 2015).

Fig. 3. Karolinka VD – seepage on the downstream face of the dam (archival photographs by PM and VD TBD)

dam. At the end of the investigation in 2004 it was already recommended that the construction of a cut-off should be considered along the entire length of the dam because all findings had shown a potential risk to the filtration stability during the extreme stages of the water level in the reservoir. The Pöyry Environment a.s. Company (today AQUATIS, a.s.) prepared project documentation for the work contractor – EUROVIA CS, a.s. to carry out the construction. The additional sealing of the core of the dam was designed using a conventional underground cut-off wall from self-hardening cement-bentonite suspension. In order to obtain a building permit a change of the design of the addi-

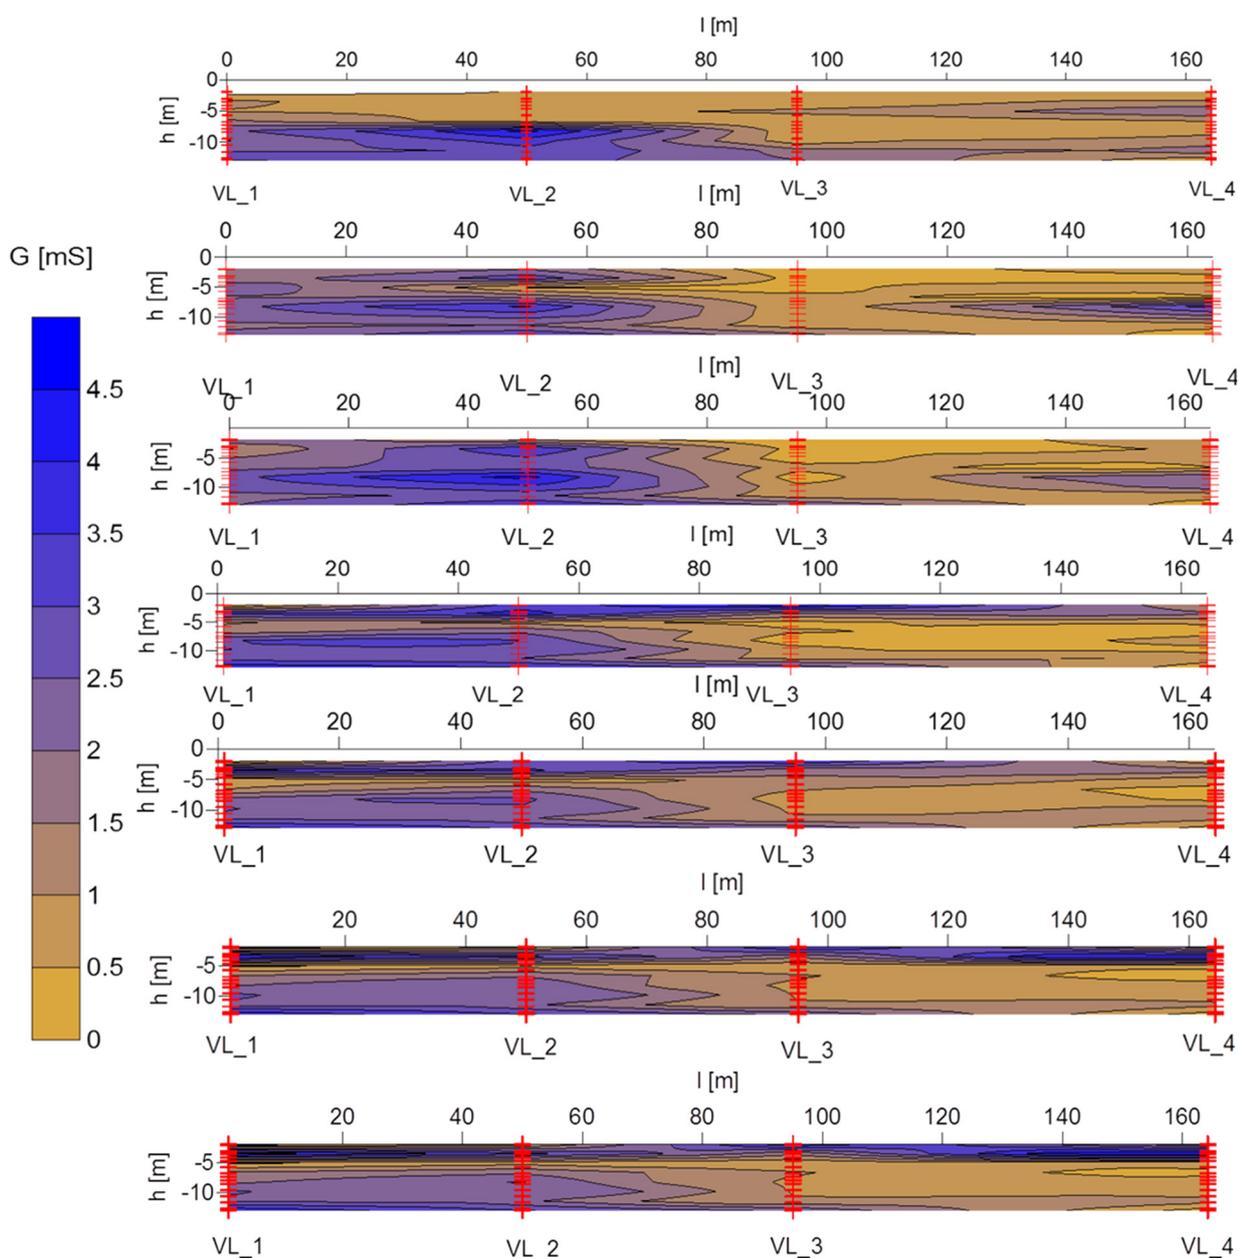
Fig. 7. Maps of the electrical conductance of the soil of the monitored section of the earth-fill dam for the month of March, 2011 to 2017 (sorted successively)

Based on the results of measurement it can be stated that the measured G values reach extremes after reconstruction essentially at the same height level as before reconstruction. However, after reconstruction, the higher G values are reached at higher water levels

In sum, it can be said that in the area of the largest seepage, at a height of –5 m to –10 m between probes VL_1 and VL_2, the values of electrical conductance of soil has been significantly reduced after the reconstruction, and thus the degree of water saturation of pores has probably decreased as well. A similar conclusion can also be drawn for the given range of heights in case of probe VL_4. In this respect it is possible to describe the application of the cut-off wall as efficient.

When studying the patterns of electrical conductance measured by probe VL_1, it is evident that the area of the higher degree of water saturation of soil pores has shifted lower, approximately to a height of –10 m to –11 m (the cut-off wall has a variable length from –10.50 m to –19.30 m). After the reconstruction, VL_1 probe was located in a part of the dam closest proximity of the cut-off wall at about –11 m, and water probably flows under the wall, which is also documented by the numerical model. Although the value of the newly formed extremum is lower than the value of the higher-located one from 2012, it is however necessary to point out that it is steadily slightly increasing during the year. In the other probes, which are located in the zone of a larger distance from of the cut-off wall, at approximately –19 m, this area of a significant increase of the values of electrical conductance and thus of the increased degree of water saturation of soil pores does not occur, which is also supported by the decreased value of the measured total seepage. A partial increase of G relative to the year 2012 can also be observed in the lowest levels of measurement in VL_4 probe, here however the extremum is not so visible and its value fluctuates during the year. When considering the results of measurement and their method of interpretation, it is possible to state

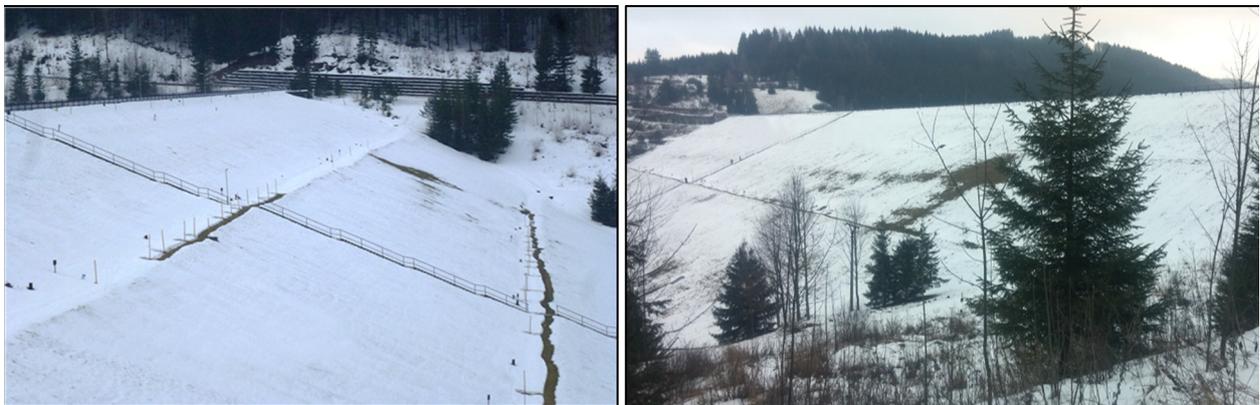
in the reservoir. In February 2015, January 2016 and February 2017, at the downstream face of the dam in the profile between the VL_1 and VL_2 probes i.e., in the left part of the dam between the upper and lower berms, seepages appeared (see: Fig. 8 and 9). The visual observations and the above statement are evidenced by increased electrical conductance values at -10.6 m and -12.9 m monitored by the monitoring EIS apparatus (see: Fig. 10).

Fig. 8. Observed seepages in February 2015, January 2016 (photo by J. Pařílková)

that the depth of the constructed cut-off wall in the area of VL_1 probe is insufficient. This conclusion is also supported by the fact that in February 2015 as well as in January 2016 an inrush area re-appeared approximately in the zone of the original historical inrush of water (where snow melted). The situation that had arisen was solved by conveying seepage down to the new drain in May 2016, but the cause of the inrush of water has not yet been satisfactorily identified. The cause can be, e.g., the water flowing on the slope or precipitation water can pass through the drainage mat or the water may come from the reservoir, then flow underneath the cut-off wall and subsequently pass through the drainage mat; but this may also concern the combination of both these causes. It is however necessary to consider also a scenario with a failure of the cut-off wall.

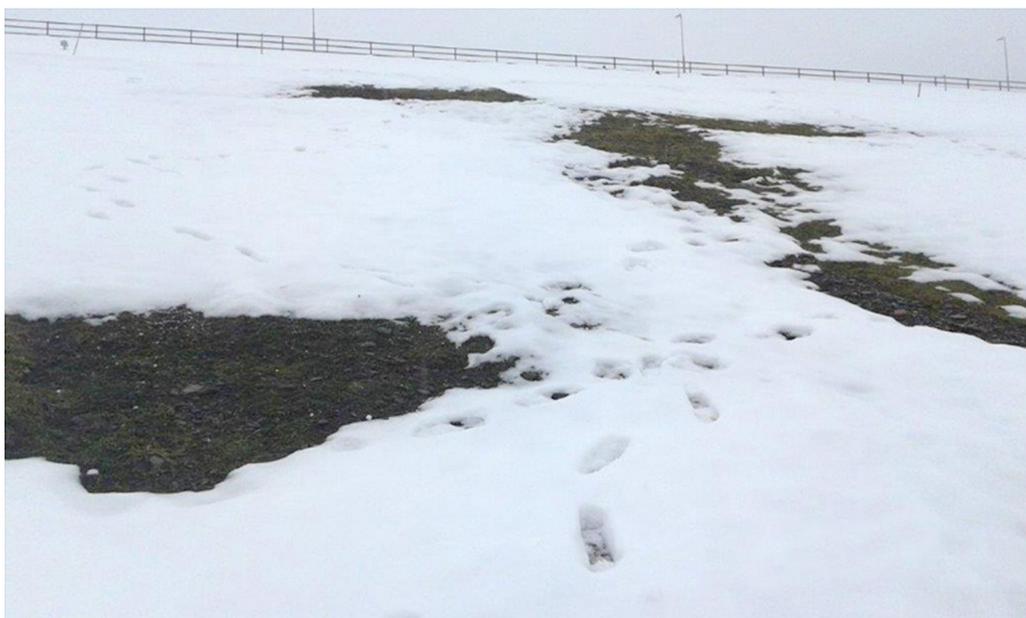
Fig. 9. Observed seepages in February 2017 (photo by Burdíkóvá)

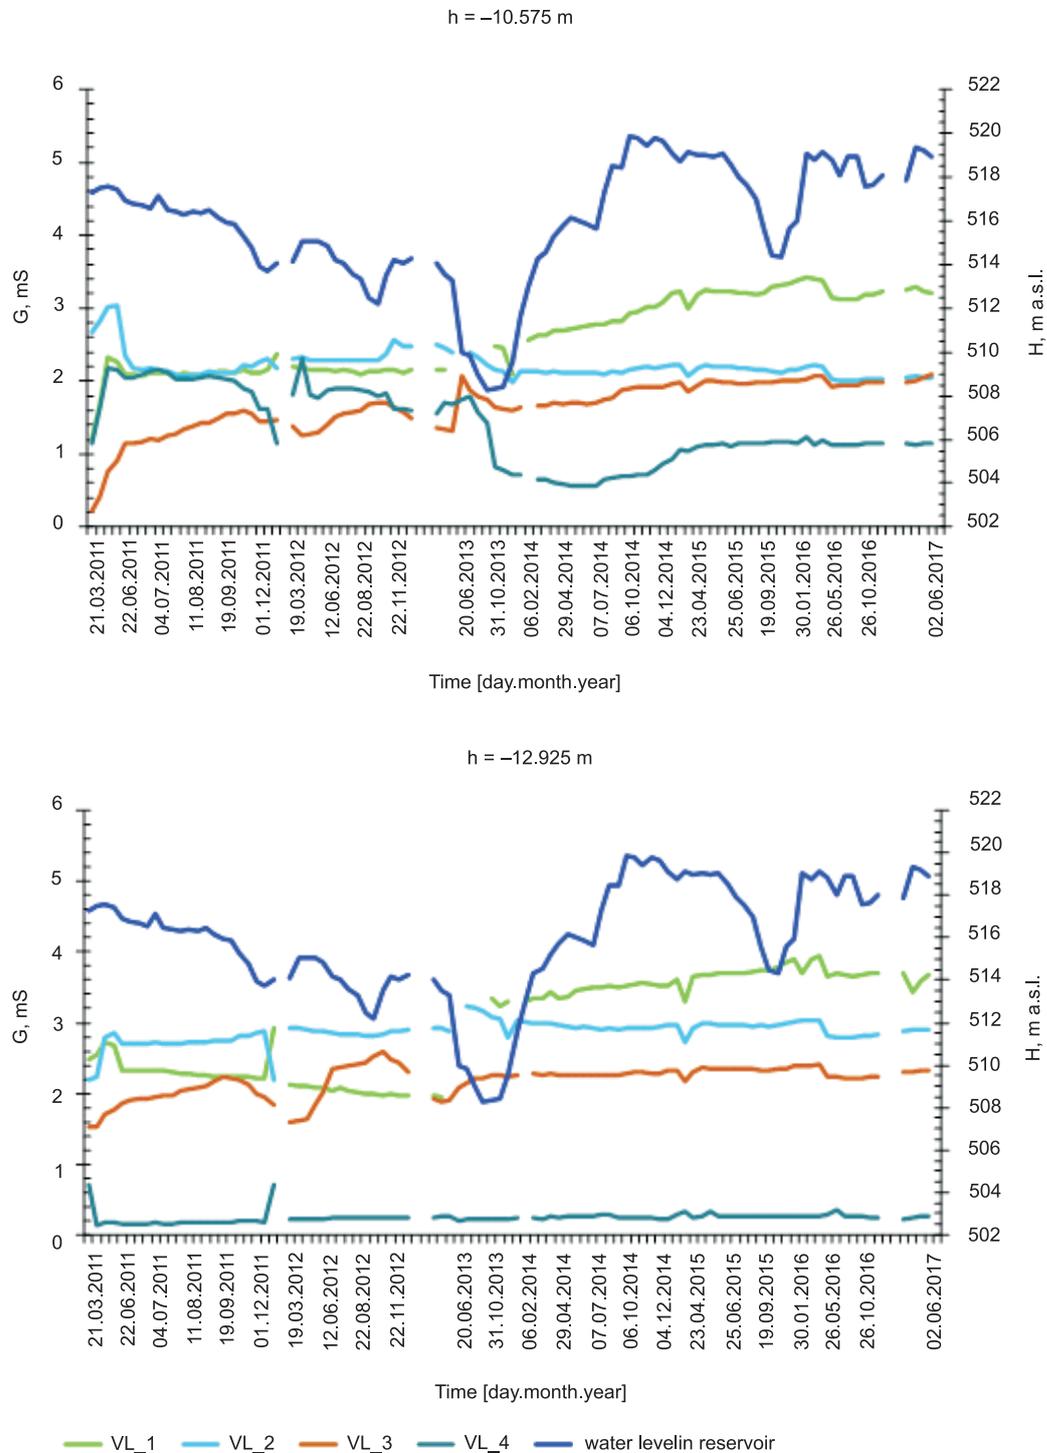
Fig. 10. The course of electrical conductivity of the soil at selected levels and the water level in the reservoir between 2011 and 2017

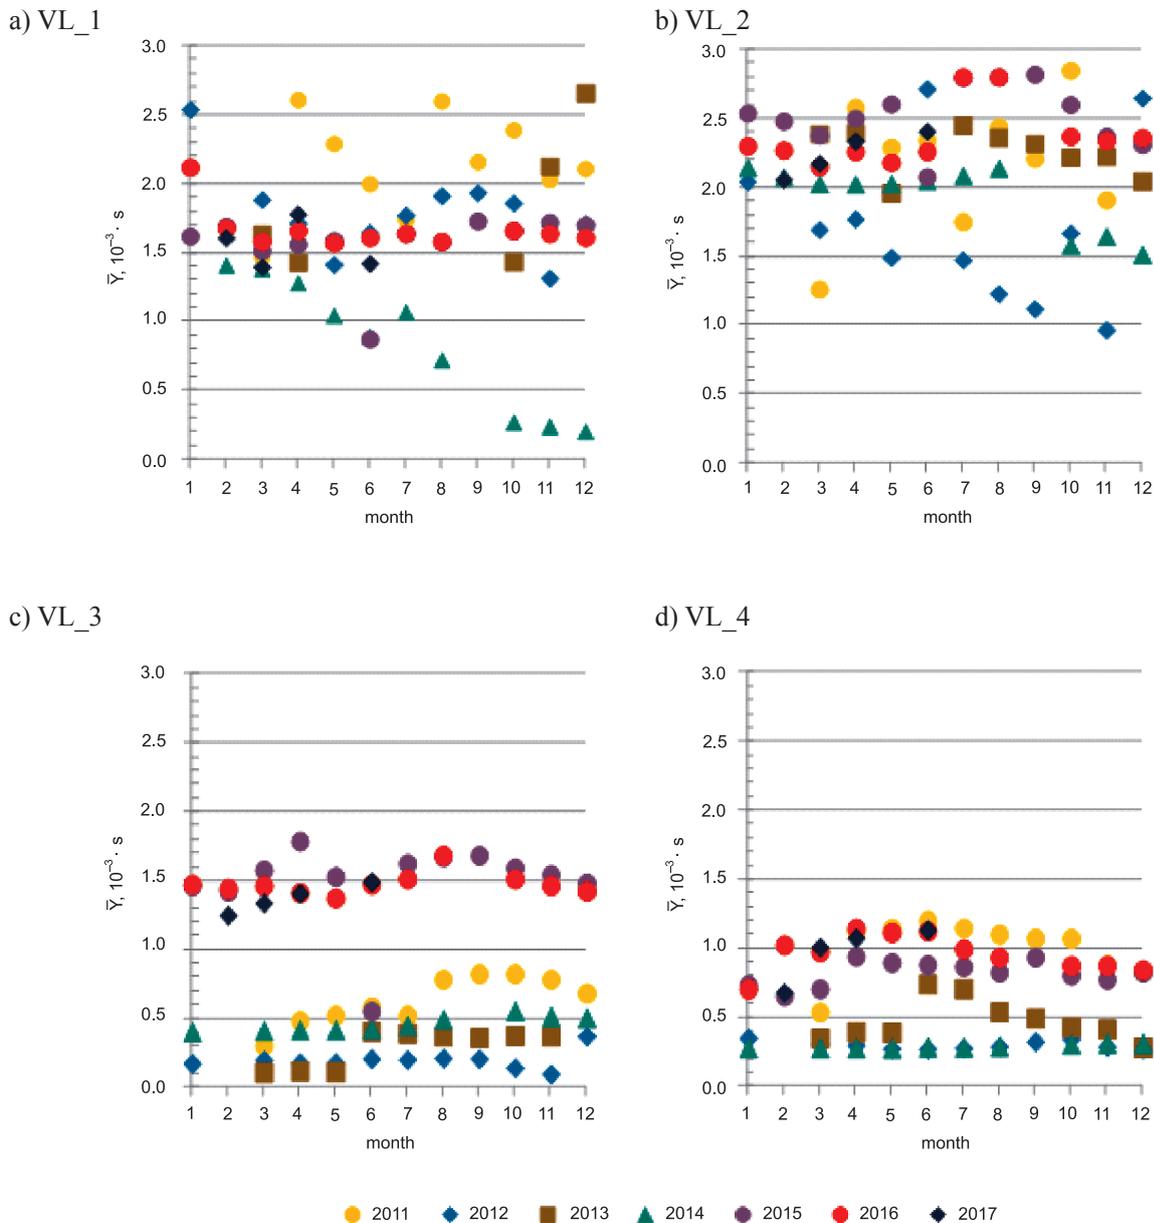
Fig. 11. Time pattern of total average values of admittance for each EIS probe from 2011 to 2017

significant quantitative change in the values of \bar{Y} was recorded by probe VL_3 in 2015 and the trend is also kept in 2016 and 2017. Whereas in 2014 it is possible to state that the values on probes VL_2 to VL_4 were stable during the year (on probe VL_1 even with a distinctly diminishing trend corresponding to the decrease in water content in the soil), in 2015, 2016 and in the measured months of 2017 this does not hold true. The values of \bar{Y} on probes VL_2 and VL_4 in 2016 and 2017 are at the level measured in 2011. All probes recorded the same or higher values than in 2012, i.e. before the installation of the cut-off wall. The decreasing pattern of the values of \bar{Y} in 2014 with an increase of the water level in the reservoir simultaneously with an approximately 40% decrease of the values of \bar{Y} relative to the same months in 2012 would evoke a high efficiency of seepage prevention made by the cut-off wall, but the facts from the years 2015 and 2016 do not support this theory (Fránková 2015), which was also documented by the data in the measured months of 2017. Higher values of \bar{Y} are still shown on probe VL_2. They demonstrate that the content of water in its surroundings is probably by about 20% higher as compared to the year 2012 in the months from September to February; the trend is slightly diminishing and related to weather conditions. An inrush of water has been observed around probe VL_2 which was remediated in May 2016 and the seepage is monitored. Nevertheless, a new seepage area was targeted in February 2017 (see: Fig. 4). Higher values \bar{Y} also occur between 2015 and 2017 on the VL_3 probe.

It is also necessary to draw attention to the increase of the values of electrical conductance in the area of about –2 m to –4 m beneath the dam crest, which is the most significant on probe VL_3; it can be partially observed on the other probes as well.
