ASSESSMENT OF TECHNICAL CONDITIONS OF BANK PROTECTION OF WATERCOURSES AND RESERVOIRS IN THE CITY OF POZNAŃ

ABSTRACT

The aim of presented paper was to assess the technical conditions of bank protection in Poznań on following hydrotechnical structures: the Warta River, Cybina River, Malta Lake, Rusałka Lake, Bogdanka River, Sołackie Ponds and the Główna River.

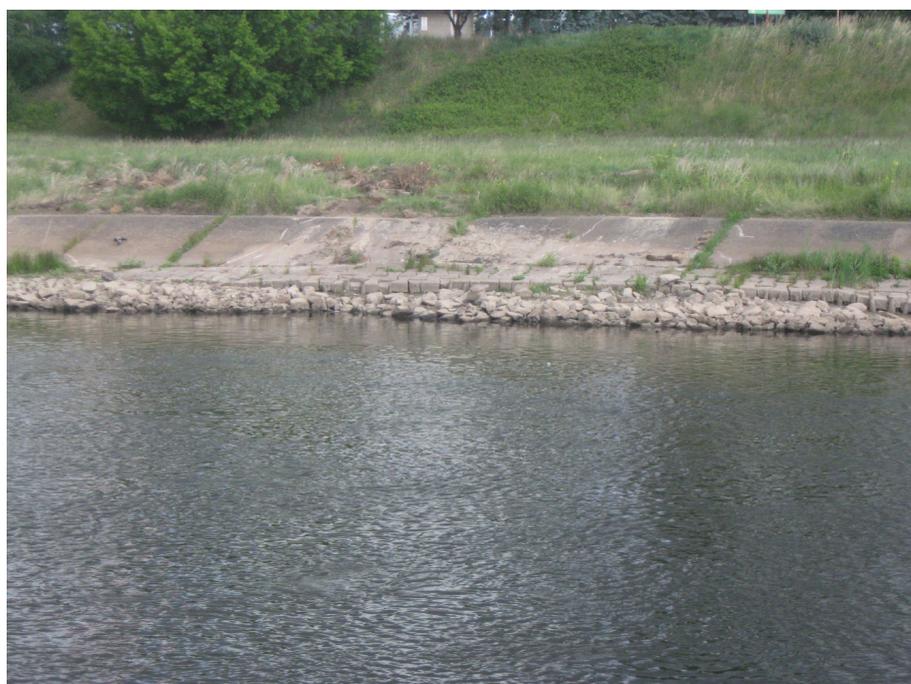
The reinforcements of the Warta embankments on the urban section of Poznań include concrete slabs supported from below with concrete elements (drainage dowel, dovetail), with a palisade and stone covering below (see: Fig. 1). Some fragments of reinforcement (especially the flexible) built about 50 years ago are in worse condition, however, they received a good grade – 4.

Fig. 1. View of bank protections of the Warta River on the Poznań section

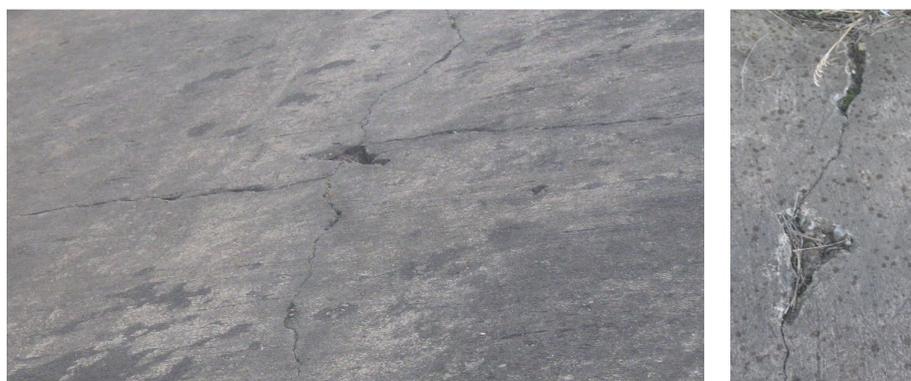
Concrete slabs (see: Fig. 2 and 3) are cracked in some places or surface corrosion of concrete has advanced (grade: 3), along the concrete defects are visible (grade: 2).

Fig. 2. Scratches (a) and cracks (b) of rigid concrete slab

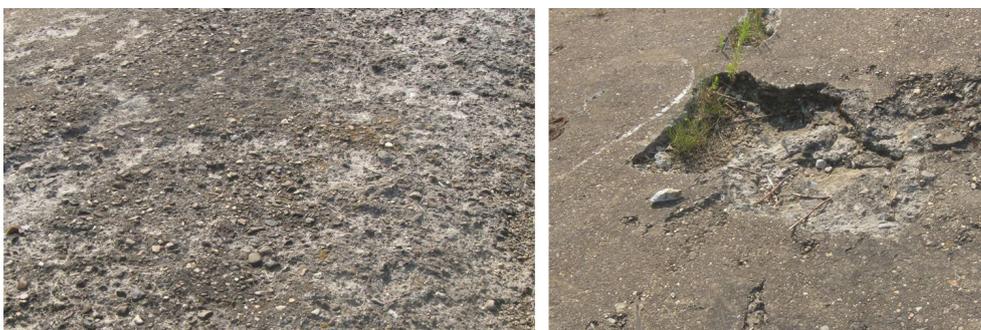
Fig. 3. Surface corrosion (a) and cracks (b) of concrete slab

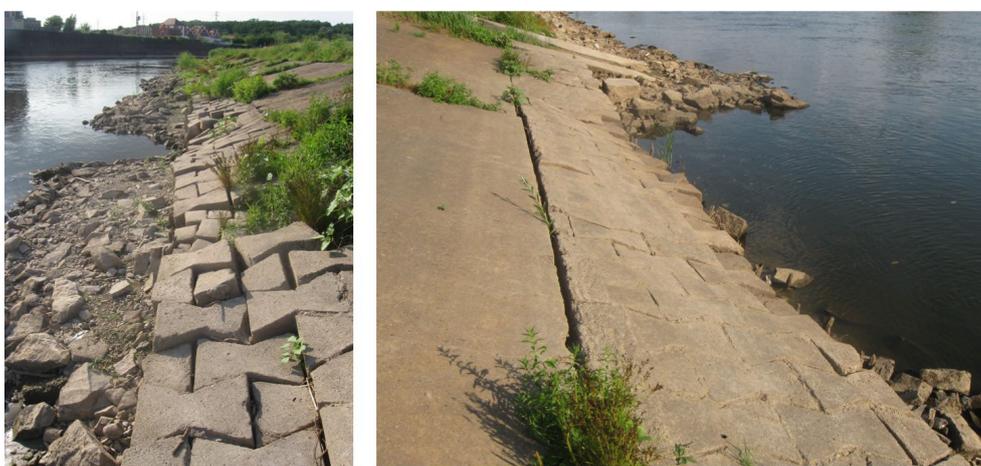
Fig. 4. Unsatisfactory or poor flexible strengthening on the Warta

On selected sections of the river (see: Fig. 4), unsatisfactory or poor conditions of flexible reinforcements were observed: concrete dowels subsided and displaced (grade: 2), and below them the surface of a protected embankment and the riverbed is exposed due to a lack of stone coating (grade: 1). Reinforcement surface is uneven, the gaps are expanding between individual elements as well as between both rigid and flexible strengthening.

Proceeding deterioration and stone losses in the flexible strengthening were caused, in particular, by an intense movement of tourist ships and motor-powered boats in 2016 and 2017. During this period, water levels remained below the lower edge of the riprap, i.e. at a level where banks were not reinforced. An additional factor affecting the deteriorating con-

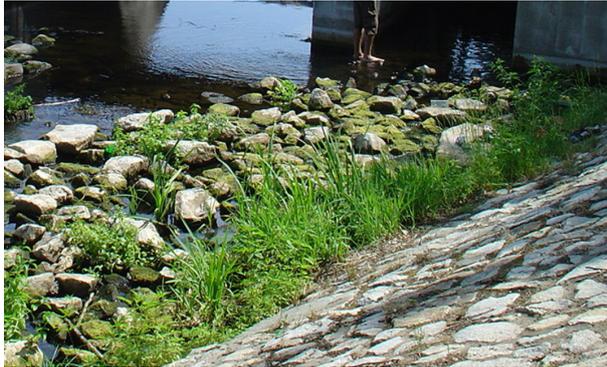
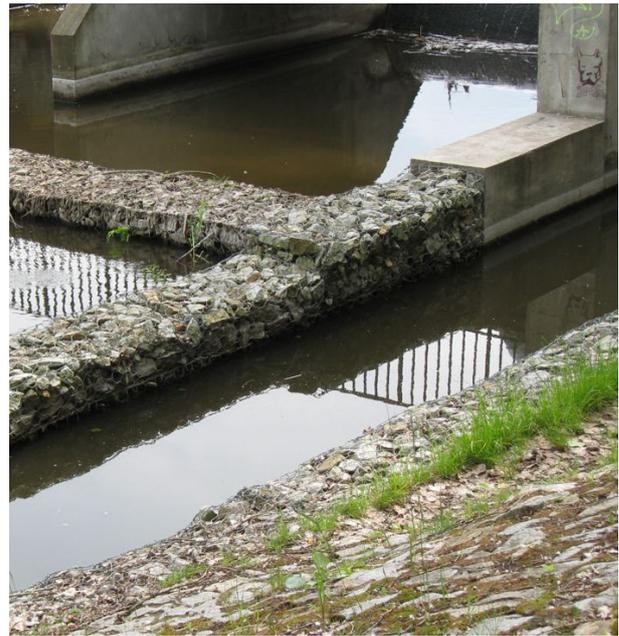
Before the modernization of the lower site of the Antoninek weir banks were protected by a loose stone coating. This enabled uncovering and bank erosion by

moving stones, which could cause instability of the structure (grade 2).

After modernization, the lower site was strengthened with gabions that secure the stability of bed and slopes of the riverbed, especially the left bank (grade 5).

Fig. 5. Lower site of the Antoninek weir; a) view before (2005), b) after modernization (2009)

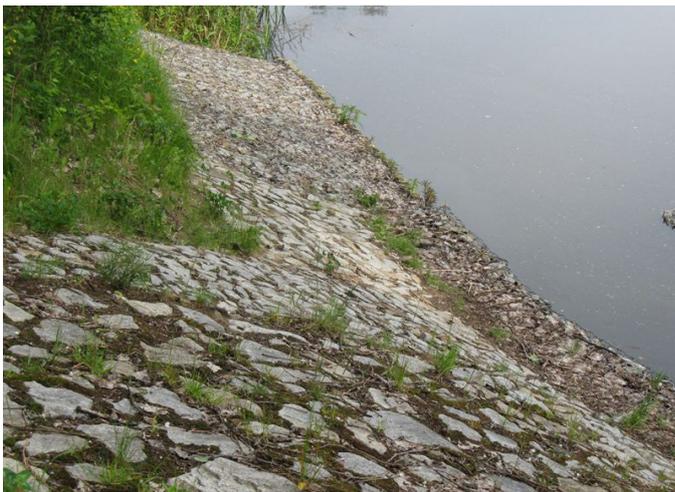
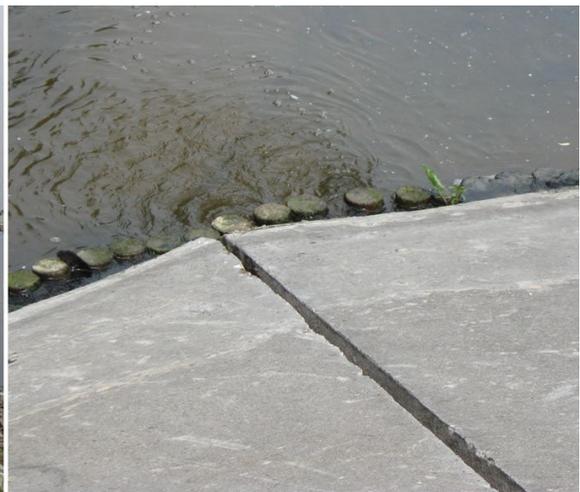
Fig. 6. Bank protection of the Cybina below the Antoninek weir: a) stone reinforcements, b) concrete reinforcements

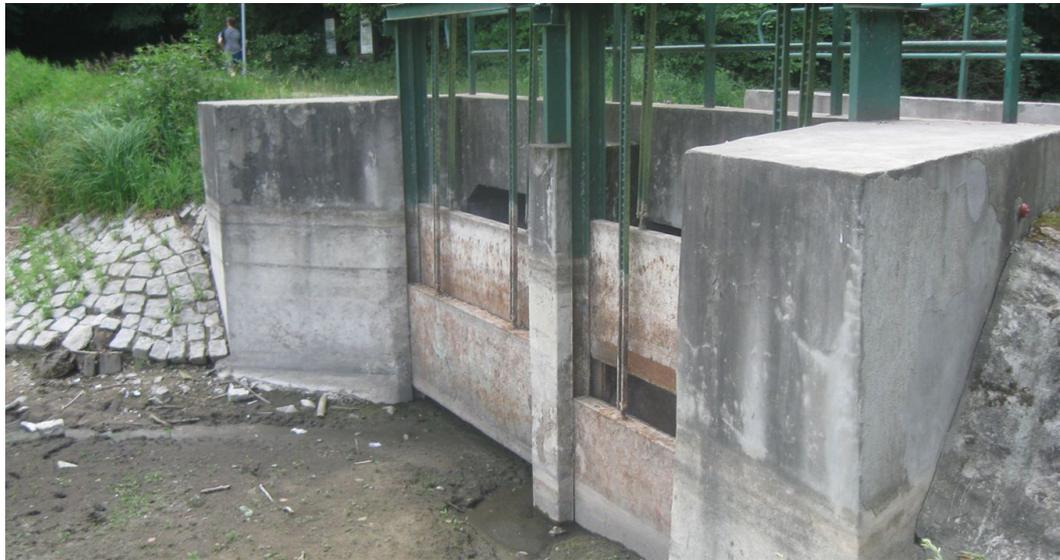
The Olszak weir (see: Fig. 7) was gradually modernized by placing granite cubes with concrete mortar on a slope of the upper site (grade 3). Due to the lack of abutment, the lower parts of the escarpment subside

Fig. 7. Upper reinforcement of the Olszak weir

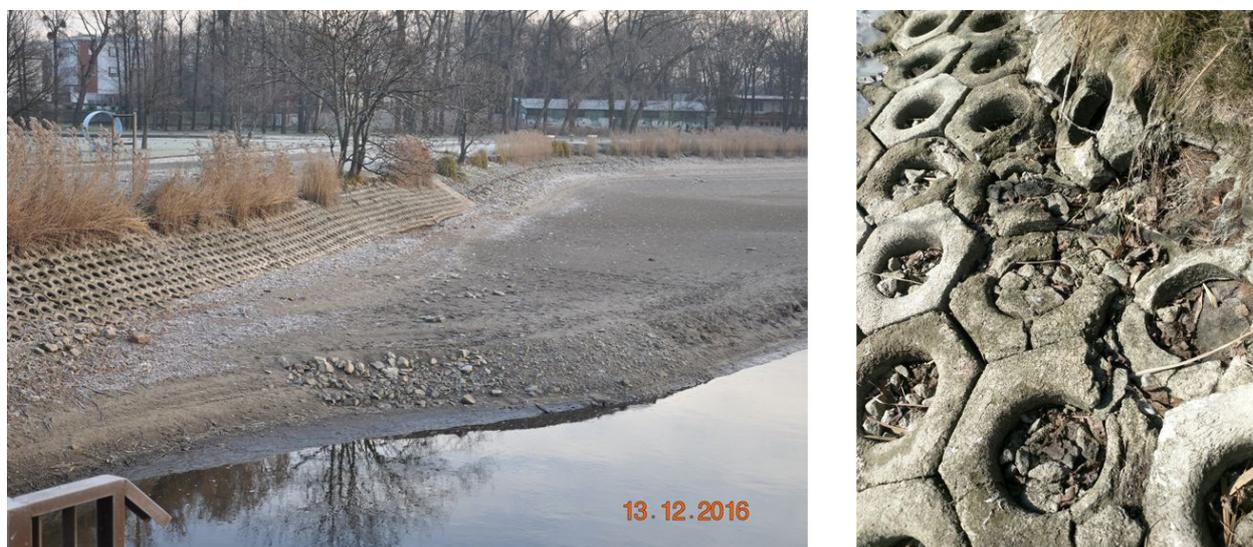
Fig. 8. Right bank of the Malta Lake: a) general view of reinforcements, b) view of structural elements of reinforcement

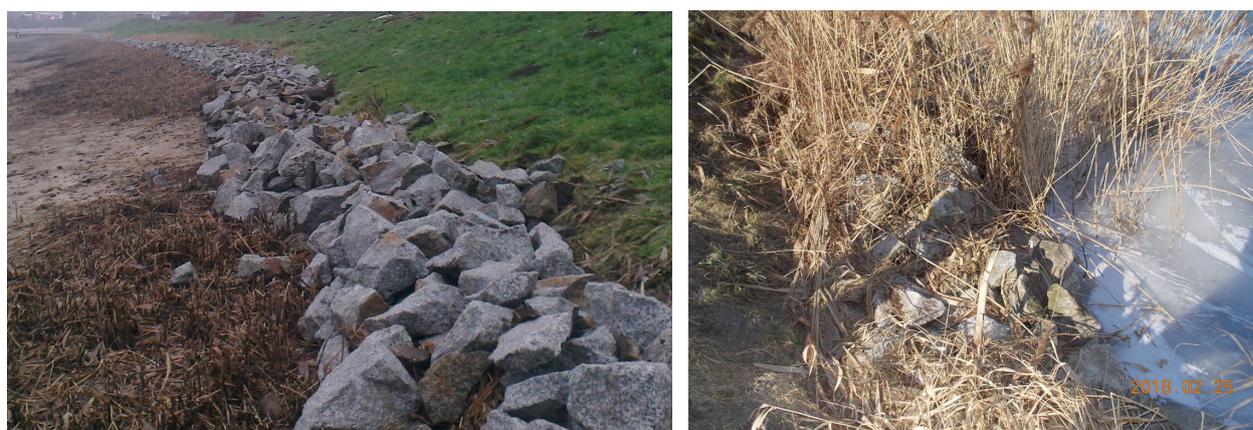
After draining the water from the reservoir (see: Fig. 9a) reinforcement conditions are assessed and

Based on photographic documentation, it can be observed that after a year of lake exploitation vegetation has overgrown the supplemented broken stone (see: Fig. 9b). Vegetation additionally protects the banks against undulation (grade 4).

Fig. 9. View of the bank protection at the bottom of the reinforced escarpment with stone coating a) after the reservoir has been emptied b) after one year of exploitation

only those fragments that have been seriously damaged undergo necessary repairs.

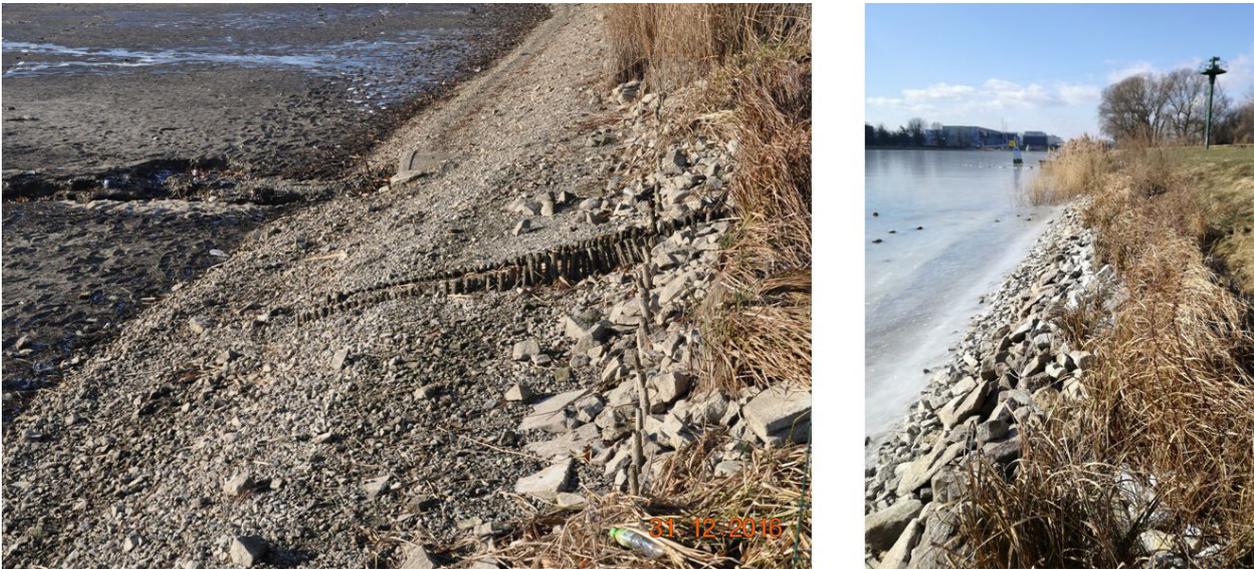
The state of reinforcements of the right bank of the Malta Lake is shown in Fig. 10. In this zone it is possible for shrub vegetation to grow across a larger area due to a gentler banks slope. The use of fascine fences improved the technical conditions of the escarpment, because the fence made it impossible to move the broken stone towards the bottom (grade 4).

Fig. 10. Right bank reinforcement of the Malta Lake: a) during the emptying of the reservoir, b) in the winter

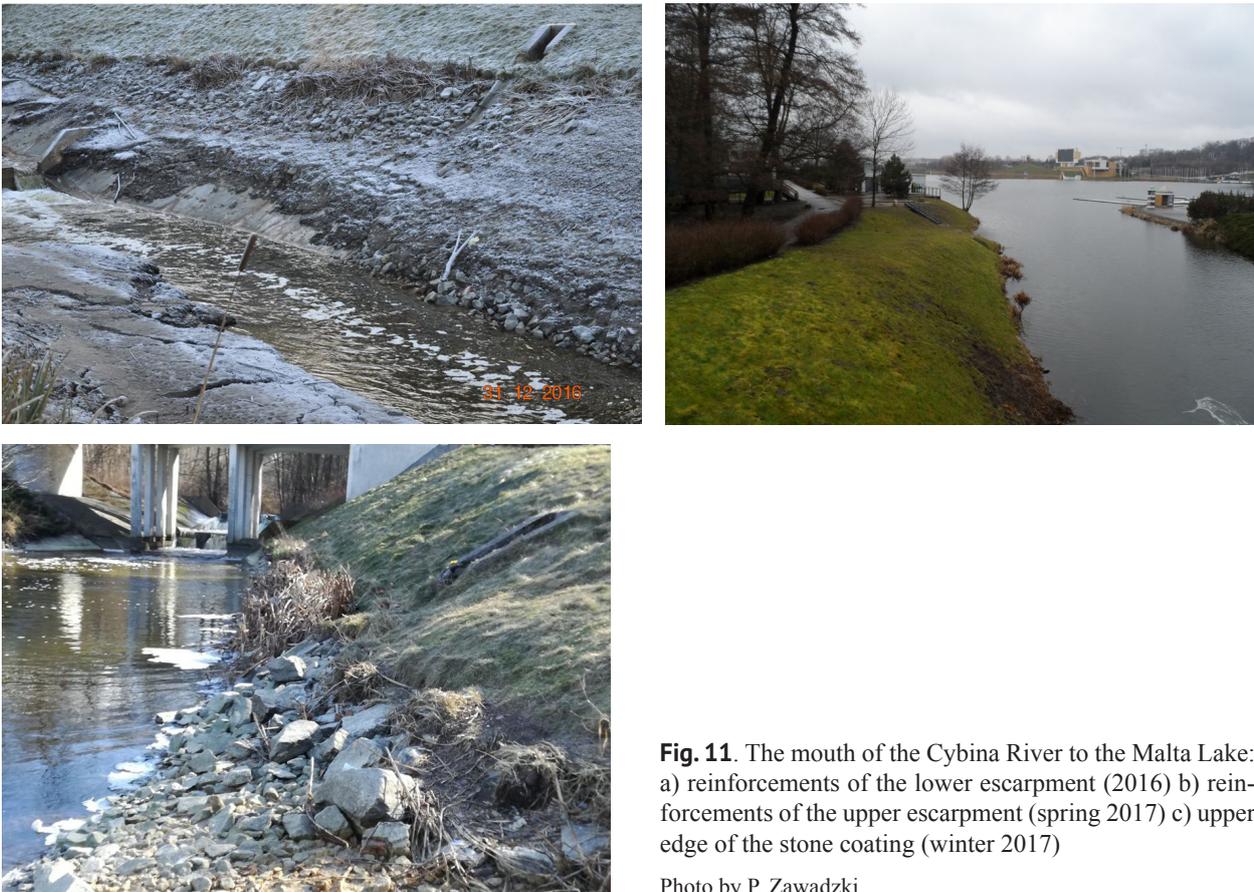
Access to the banks of Malta Lake is not limited in any way, therefore they are exposed to anthropogenic deterioration (see: Fig. 11), like throwing stone elements into the water, or in winter on ice.

Fig. 11. The mouth of the Cybina River to the Malta Lake: a) reinforcements of the lower escarpment (2016) b) reinforcements of the upper escarpment (spring 2017) c) upper edge of the stone coating (winter 2017)

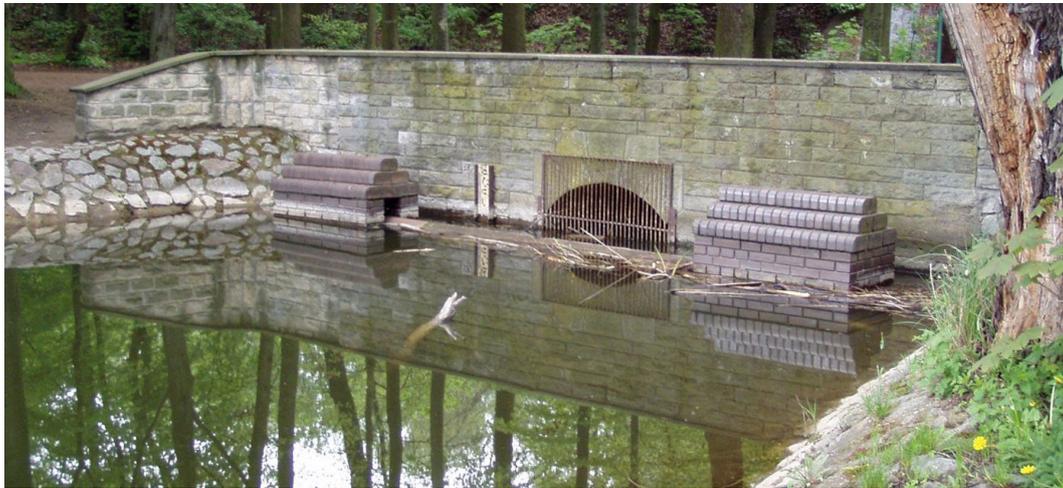
Fig. 12. Barrage of the Rusalka Lake

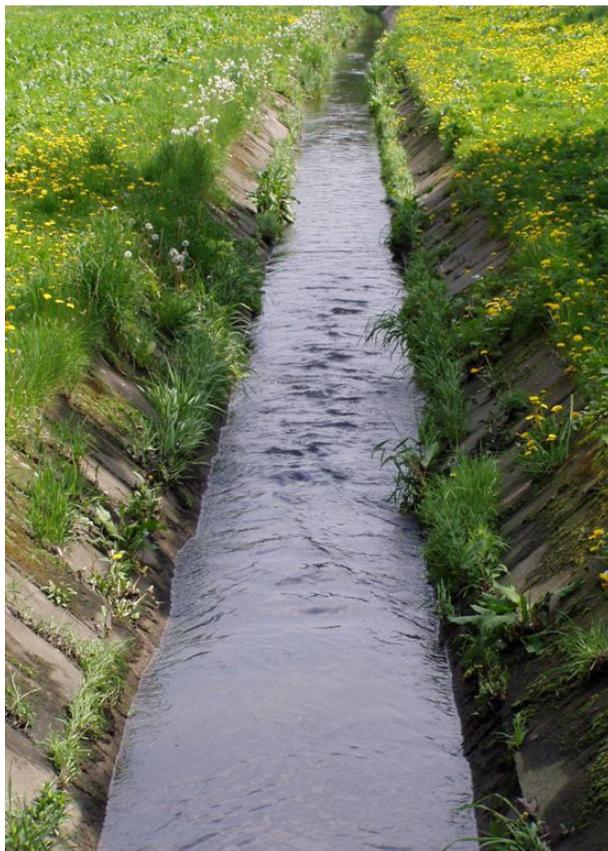
Fig. 13. Strengthening of banks of the Bogdanka below Nad Wierzbakiem Street (Wodiczka Park)

On the watercourse section below Nad Wierzbakiem Street (after being joined by tributaries), banks were strengthened with openwork concrete slabs, which were overgrown with grassy vegetation, this is particularly visible at joints of the slabs (grade 3). Immediately, due to the adopted banks slope, torrential rain and a significant increase in intensity and velocity of water flow have led to higher instability of individual slabs. It seems that this has been stopped by development of vegetation.

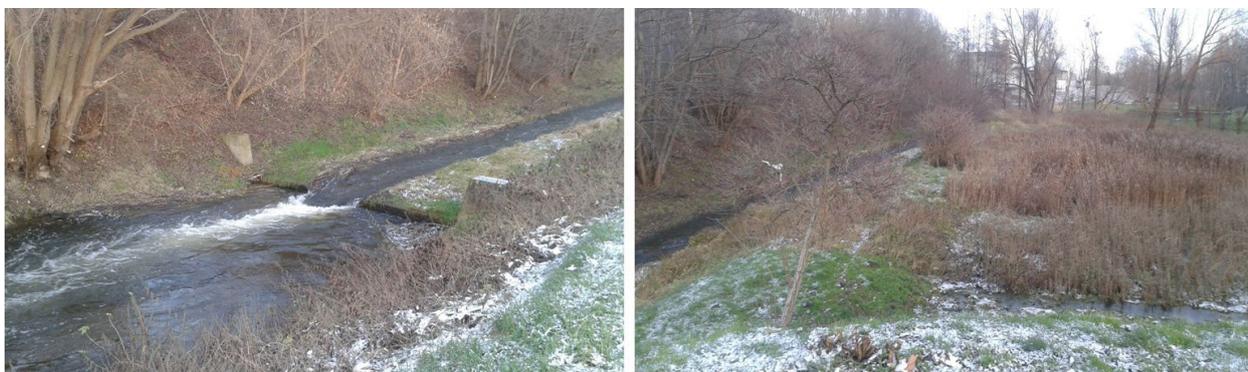
Fig. 14. The Glówna River – regulatory step in the place of the former Nadolnik mill and the pond bowl
