DAMAGED DROP HYDRAULIC STRUCTURE AS AN EXAMPLE OF NATURAL RENATURALIZATION PROCESS OF RIVER: THE DOBRZYCA RIVER, NORTH WEST POLAND

The paper presents an assessment of capacity of a drop hydraulic structure, which was partially destroyed, and provides a description of slow renaturalization of a riverbed in this area. As a result of damage to the hydrotechnical structure caused by natural processes, some elements detached from the structure were deposited in an energy dissipation basin and in the riverbed downstream of the structure, impeding rock and vegetal debris traffic. These fluvial processes formed a cascade-like structure that led to a change in the regime of water flow through the hydrotechnical structure that was not planned or designed originally.

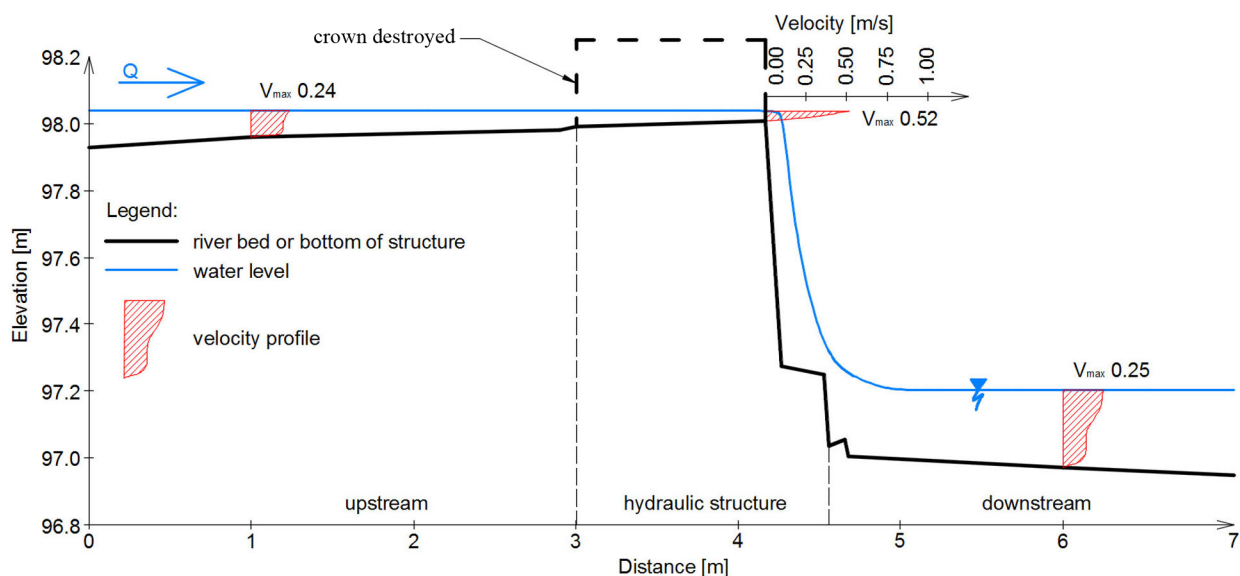
Fig. 3. Profile no. 1

Profile no. 1 was designed, where the drop hydraulic structure's shape was the closest to its original condition. Ruptured concrete slab, which was a crown of a spillway, was the most major change in this part of the structure – due to thus the spillway dropped by 0.22 m. Hydrodynamic measurements show that the

maximum flow velocities were low, reaching only $V_{max} = 0.24 \text{ m} \cdot \text{s}^{-1}$ and $0.25 \text{ m} \cdot \text{s}^{-1}$ above and below the structure respectively. In turn, at the drop hydraulic structure's spillway, velocity was $V_{max} = 0.52 \text{ m} \cdot \text{s}^{-1}$. Large water drop, which was $\Delta h = 0.9 \text{ m}$, proves capacity failure at this profile. Under such conditions, no fish species found in the river were able to make such a high and long jump.

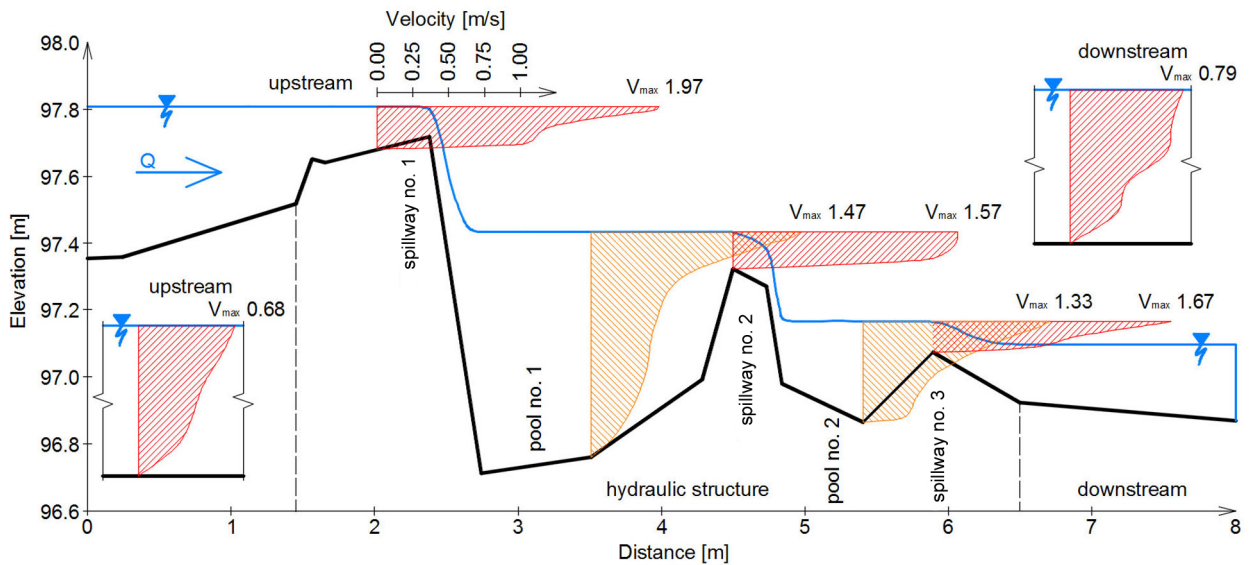
Fig. 4. Profile no. 2

Profile no. 2 was drafted to the right of Profile no. 1, which was more damaged. Below the spillway were deposited concrete elements (marked in the diagram as spillways no. 2 and 3), which were detached from the drop hydraulic structure. These elements dammed up the water, creating deep pools above the facility. Depth of the first was $H = 0.7$ m and of the second – $H = 0.33$ m. The maximum water velocity was $V_{\max} = 1.47 \text{ m} \cdot \text{s}^{-1}$ and $V_{\max} = 1.33 \text{ m} \cdot \text{s}^{-1}$ in the first and second pool, respectively, however, these values occurred at water table. In the lower parts of the pools, velocity was significantly lower, usually not exceeding $V = 0.50 \text{ m} \cdot \text{s}^{-1}$ and $V = 0.75 \text{ m} \cdot \text{s}^{-1}$. Despite favourable conditions in the pools for all of the considered fish species (except for bream, for which filling of the pool 2 was too low with $H_{\text{acc}} = 0.53$ m), the problem could be the spillways generating excessive velocity. At the two lowest spillways, maximum velocity was $V_{\max} = 1.57 \text{ m} \cdot \text{s}^{-1}$ and $V_{\max} = 1.67 \text{ m} \cdot \text{s}^{-1}$, which enabled only trout to reach the pool no. 1. Unfortunately, despite the fact that trout could enter the pool no. 1, the main spillway (no. 1) posed an insurmountable obstacle, because the water drop was too high, $\Delta h = 0.3$ m. Also, velocity of overflowing water there was very high, from $V_{\min} = 1.12 \text{ m} \cdot \text{s}^{-1}$ at the ground to $V_{\max} = 1.97 \text{ m} \cdot \text{s}^{-1}$ at water table.

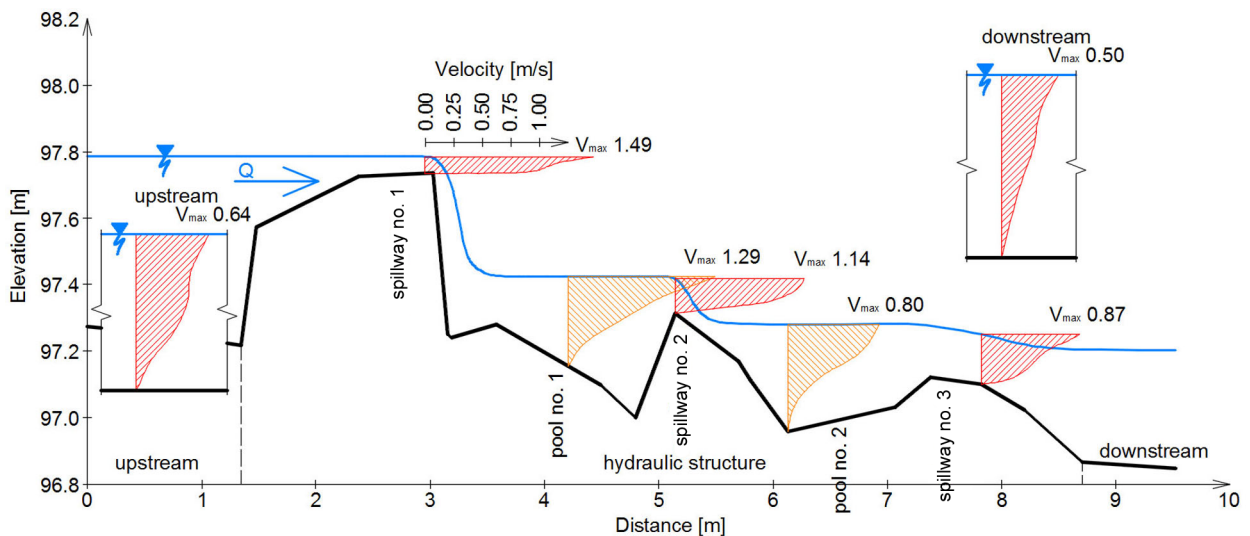
Fig. 5. Profile no. 3

Profile no. 3 was located in the central part of the structure. Wood rubble, besides concrete elements, was found in the riverbed below the structure. Excessive height of spillway crown, amounting to 0.35 m, demonstrated how choked the drop hydraulic structure was. This meant that no species of fish inhabiting the riverbed could pass through, despite significant filling of basin no. 1 ($H = 0.42$ m). Brown trout and grayling were able to reach only up to this point. In turn, despite low velocity values ($V < 1.0 \text{ m} \cdot \text{s}^{-1}$) on the spillway no. 3 and in the pool no. 2, other species of fish could not enter into the pool no. 2, because its filling ($H = 0.26$ m) and length ($L = 1.6$ m) were below acceptable values.

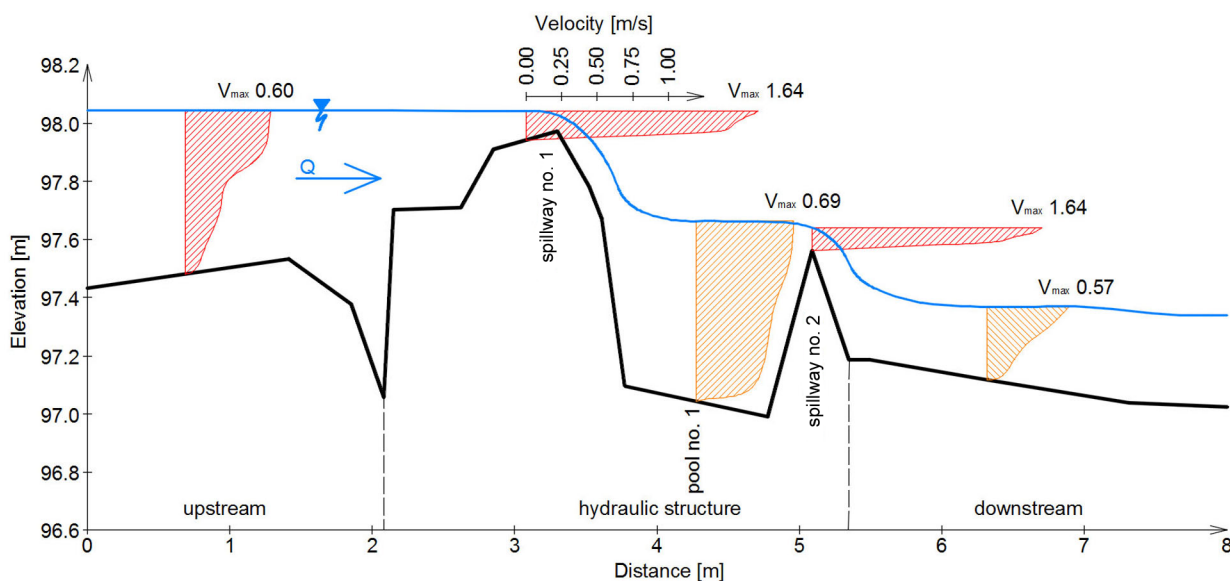
Fig. 6. Profile no. 4

Profile no. 4 was characterized by a single $H = 0.7$ m deep and $L = 1.75$ m long pool. Such a large depth created favourable spatial conditions for fish to accelerate and make a jump long and high enough to cross the obstacle. The water drop at the spillway no. 2 (below the pool) was $\Delta h = 0.19$ m, and flow velocity $V_{\max} = 1.64 \text{ m} \cdot \text{s}^{-1}$. The velocity profile has shown little variety. These parameters indicate that only brown trout could enter the pool no. 1. Above the pool no. 1 was the main spillway (no. 1) with convenient shapes (Dąbkowski et al., 1982), i.e. the stream did not escape from the structure's bed, but only slid on its surface.

Therefore, although the water drop was as high as $h = 0.35$ m, trout should be able to swim through this spillway, which is supported by the following:

1. The filling in the pool no. 1 below the spillway no. 1 is large ($h = 0.7$ m), which according to the equation is enough for trout to give a sufficiently long and high jump (Jelonek and Wierzbicki,

2008). On the other hand, according to Cowx and Welcomme (1998) this suggests that for a spillway of $h = 0.35$ m the filling of pool of $h = 0.44$ m is sufficient.

2. When water is overflowing through a spillway with a convenient shape, fish does not have to jump for gaining speed that beats the velocity of water

sliding on across the structure's bed. The maximum value of velocity in the spillway no. 1 was $V_{\max} = 1.64 \text{ m} \cdot \text{s}^{-1}$, remaining within the acceptable range. Research literature (Larinier, 2002) indicates that at a velocity of $V = 1.64 \text{ m} \cdot \text{s}^{-1}$ trout $L = 0.25 \text{ m}$ long is able to swim about 5.5 m at a water temperature of 10–20°C. For specimen of length $L = 0.35 \text{ m}$ this distance increases significantly above 10 m. Even with taking into account the length of the drop (0.37 m), and not the drop itself (0.35 m), it can be unambiguously stated that flow velocity on the spillway will not impede migrating trout.

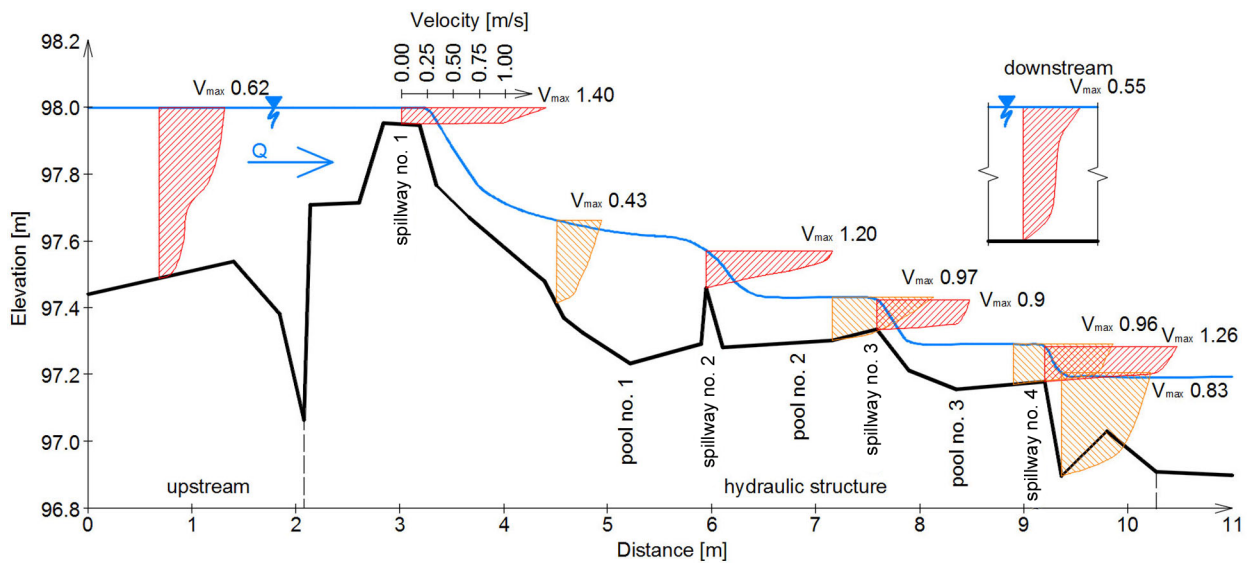
Fig. 7. Profile no. 5

Profile no. 5 was located on the right side of the object, in a place where most of the vegetal debris was deposited, which along with elements detached from the main spillway led to a stepped water table profile. Three limiters were found in this profile, which block

the entire structure for all fish species. These are: pools no. 2 and 3 and the main spillway no. 1. Pool no. 3 was characterized by very low filling ($H = 0.1 \text{ m}$) and too small dimensions ($L = 1.3 \text{ m}$) meaning that these parameters were outside the norms for all species of fish found in the river. Also in pool no. 2 the filling was too low – $H = 0.17 \text{ m}$. The third element causing a blockage in fish migration was the main spillway (no. 1) with a $\Delta h = 0.36 \text{ m}$ high drop.

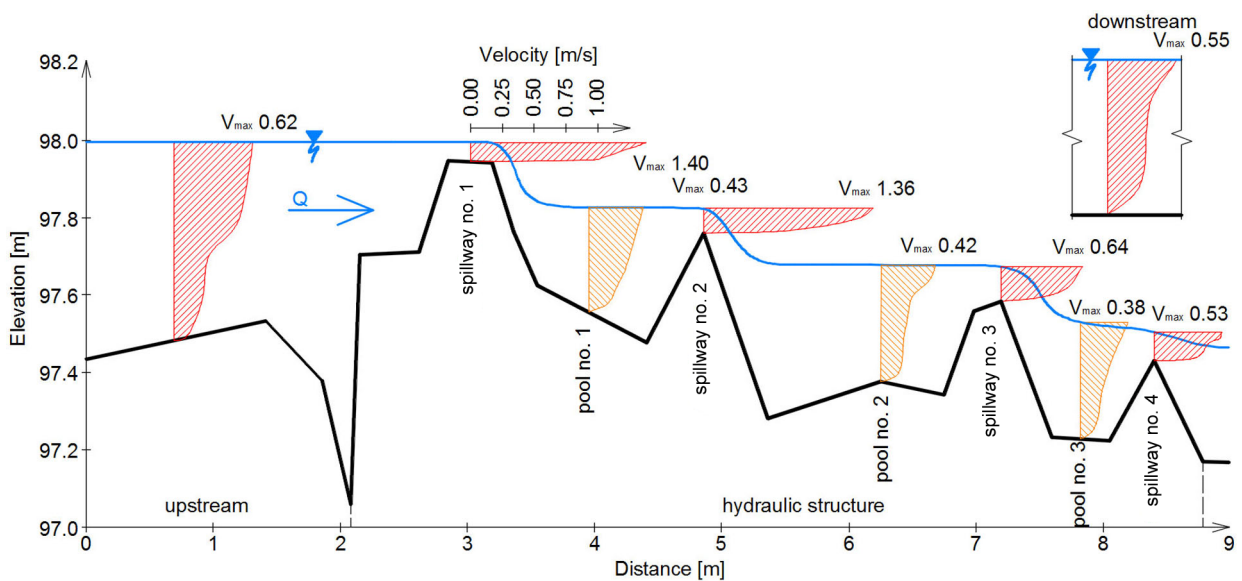
Fig. 8. Profile no. 6

The results obtained from the measurements of profile no. 6, which was located on the right side of the facility, indicate that this part with has the highest capacity. It poses no difficulty for trout, grayling, roach and perch. All of these fish species are able to pass through the spillway no. 1, which features the worst hydrodynamic parameters in terms of fish migration. The water drop here is $\Delta h = 0.13 \text{ m}$, while flow velocity reached $V_{\max} = 1.4 \text{ m} \cdot \text{s}^{-1}$. At spillway no. 2, water flow velocity was similar ($V_{\max} = 1.36 \text{ m} \cdot \text{s}^{-1}$) to that observed at spillway no. 1, while the water drop was only $\Delta h = 0.08 \text{ m}$. The next spillways (no. 3 and 4) were much slower than these situated above. Their maximum values were respectively $V_{\max} = 0.64 \text{ m} \cdot \text{s}^{-1}$ and $V_{\max} = 0.53 \text{ m} \cdot \text{s}^{-1}$ for no. 3 and 4 and the water drop itself was much smaller. At spillway no. 3 it was $\Delta h = 0.05 \text{ m}$, while spillway no. 4 was below water

table. On the basis of analysis of hydrodynamic parameters alone it could be proven that fish species with worse jumping and swimming abilities (bream, pike, eel and burbot) could reach pool no. 2. Pool no. 3 could be a significant impediment for mentioned fish, because it was too short ($L = 1.5$ m) and for some species also too shallow ($H = 0.35$ m).
