HYDRAULIC CONDITIONS OF WATER FLOW IN SEMINATURAL FISH PASS, A CASE STUDY OF THE SKÓRKA BARRAGE ON THE GŁOMIA RIVER

Mateusz Hämmerling, Tomasz Kałuża, Natalia Walczak

Poznan University of Life Sciences

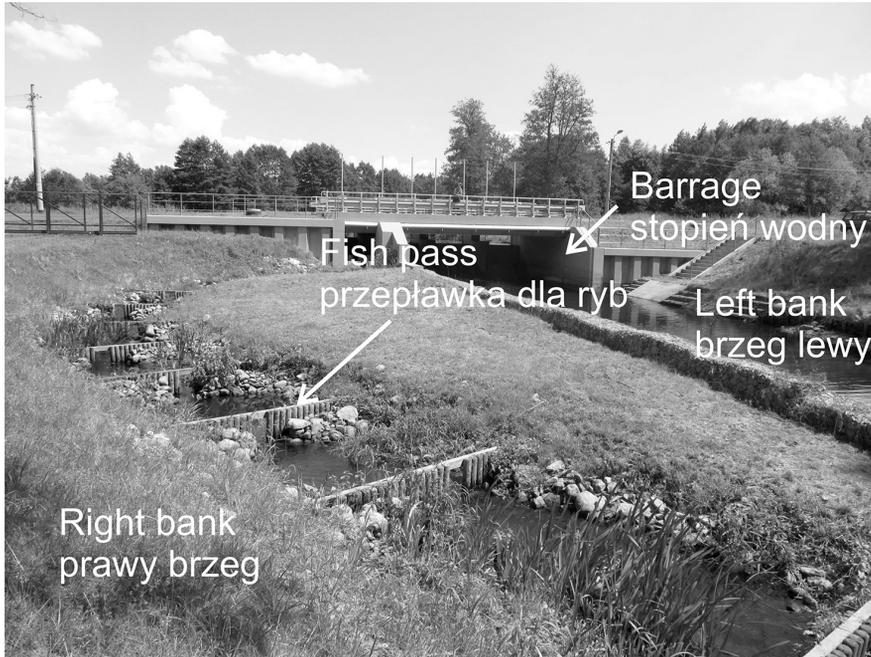
Fig. 1. View of Skórka barrage from the bottom

the cross-section is 568,7 km² (Fig. 2). A view of the weir and the fish pass at the Skórka barrage on the Głomia river is shown in Figure 1. The damming structure corresponds to the fourth class of importance of hydrotechnical structures according to the Regulation of the Minister for the Environment of 20 April 2007 concerning the technical conditions for hydrotechnical structures and their locations [Regulation... 2007]. It is a dock, reinforced concrete structure consisting of three spans with steel single-casement valves. Each span has a width of 3.0 m, thus the total cross section is 9.0 m. The barrage allows a reliable flow discharge, equal to $SSQ = 2.81 \text{ m}^3 \cdot \text{s}^{-1}$, for which the weir was designed, gross head of the dam is 2.59 m.

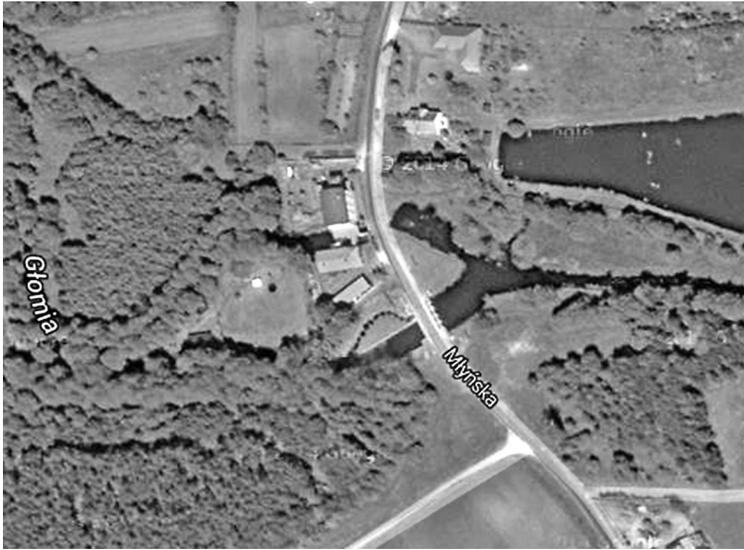
Fig. 2. Plan of the Skórka barrage (<http://earthexplorer.usgs.gov/>)
