DIFFICULTIES WITH EXISTING FISH PASSES AND THEIR RENOVATION. THE POOL FISH PASS ON DŁUBNIA RIVER IN KRAKOW

The aim of study was to determine, how the pool fish pass located on the Dłubnia River operates and to formulate recommendations, due to which it will work effectively and will not be an obstacle for migrating fish.

Aim of the study is to assess the technical condition of a pool fish pass in a weir pillar on the Dłubnia River in Cracow. Research included field work, assessment of technical conditions in terms of possibility of fish migration through the aforementioned fish pass and the elaboration of recommendations for improving that will restore functionality of the structure.

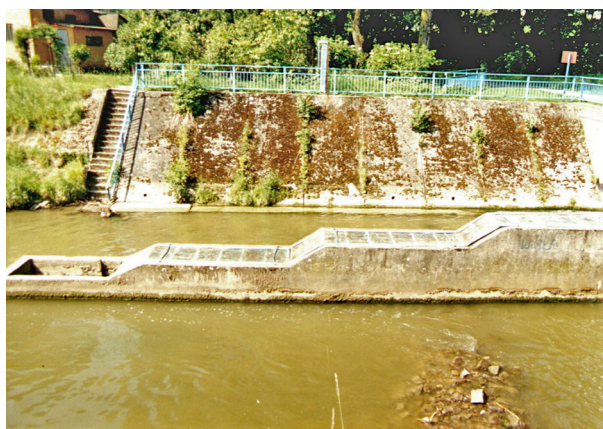
Fig. 3. Fish pass on Dłubnia River – longitudinal profile, side view (photo: A. Radecki-Pawlik)

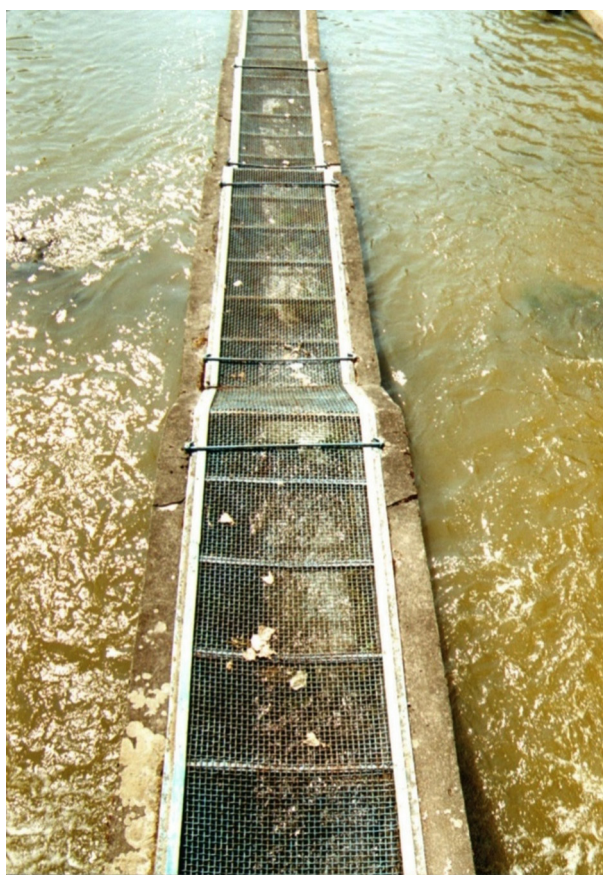
Fig. 4. Fish pass on Dłubnia River – top view (photo: A. Radecki-Pawlik)

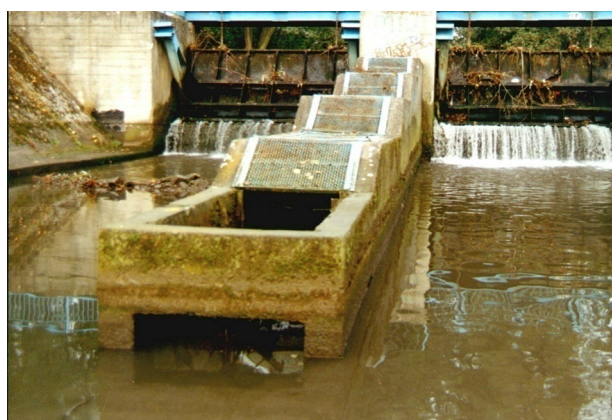
Fig. 5. Fish pass on Dłubnia River – view from downstream after draining the river channel (photo: G. Gajda)

and vegetation overgrew, which has found excellent conditions for development thanks to water flowing through leaky valves, covering walls, pools and partitions of the passage and reducing its clearance. At present stage it is flexible vegetation that has not led to any significant damage, however, allowing its development into rigid vegetation will cause further and much more serious detriment. It was also noticed that the outlet pool is completely blocked by anthropogenic contamination.

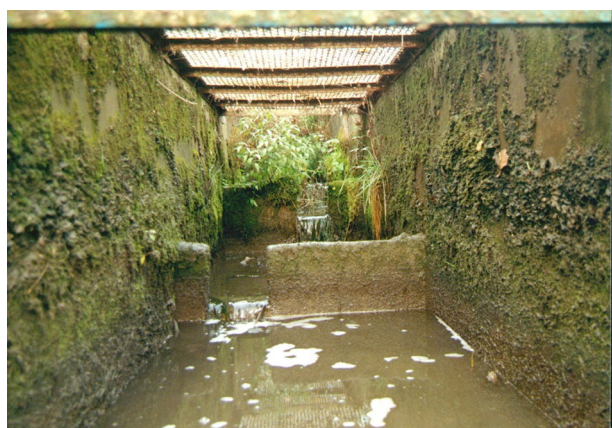
Fig. 6. Fish pass on Dłubnia River – inside view after draining the river channel (photo: G. Gajda)

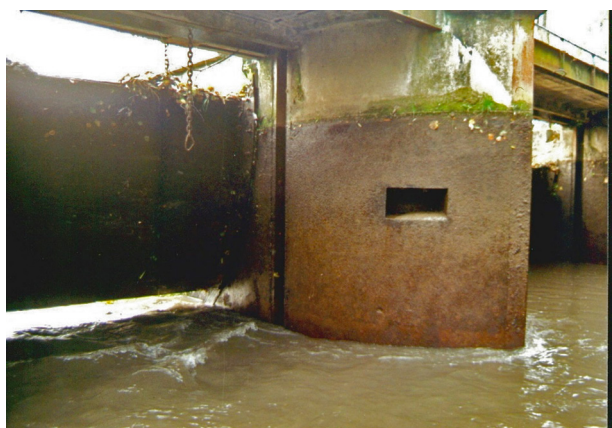
Fig. 7. Fish pass on Dłubnia River – view of intake to fish pass through the river channel and the upstream reservoir (photo: G. Gajda)
