## THE WARTA RIVER VALLEY IN THE DĘBINA AREA OF POZNAŃ – CHANGES IN LAND COVER AND LAND USE IN THE CONTEXT OF NATURAL ASSETS AND LANDSCAPE QUALITIES

Bożena Łukasik<sup>✉</sup>, Agnieszka Wilkaniec, Agnieszka Targońska

Department of Landscape Architecture, Poznań University of Life Sciences, ul. Dąbrowskiego 159, 60-594 Poznań

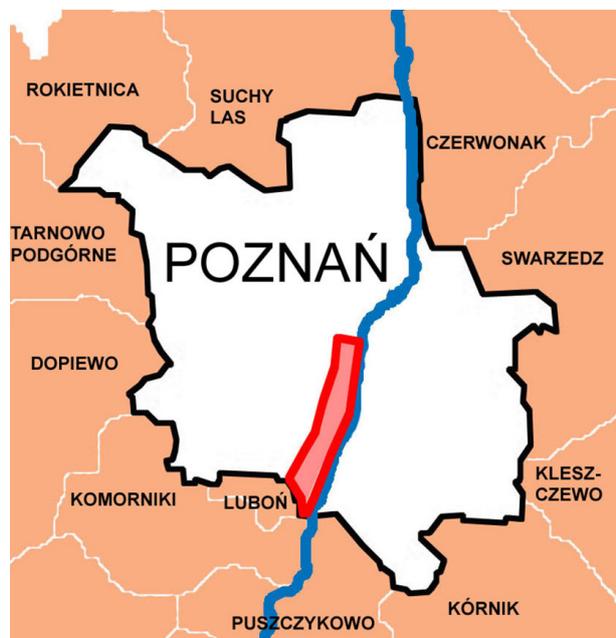
**Fig. 1.** Location of the research area (Source: compiled by B. Łukasik)

eastern border was marked by the course of the river. A part of this area consists of ecological sites of Dębina I and Dębina II (see: Fig. 1).

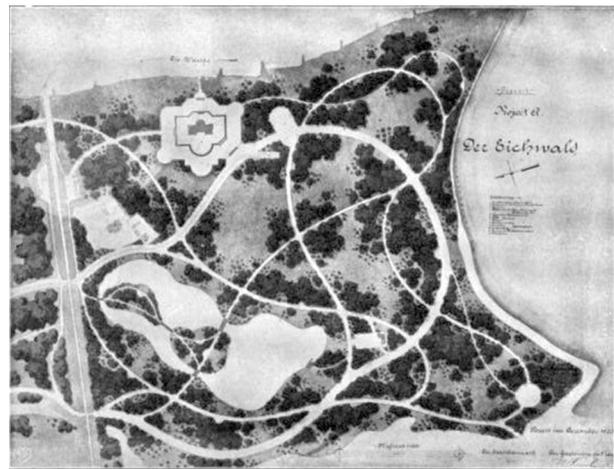
**Fig. 2.** The plan of Dębina forest park – 1900 (Source: Hoffmann, 1900)

In 1900, a project was put in place to transform Dębina into a folk park, the authors of which were garden inspector Hermann Kube and municipal building councillor Fritz Teubner (Karolczak, 1993). The plan showed smoothly routed alleys with a clearly marked ring road, areas with groups and massifs of trees, and open clearings between them (see: Fig. 2). The form and manner of spatial development of this area referred to the solutions of the nineteenth-century landscape parks. In the area of the park that was being developed, the question of water relations required regulation most particularly – as it was necessary to

fill the landlocked swamps, as well as to form picturesque ponds connected to form a system maintaining an even water level. These works were interrupted by the outbreak of the First World War (Karolczak, 1993). After the war, they continued, although the importance of Dębina as a recreational area for the city's residents gradually decreased.

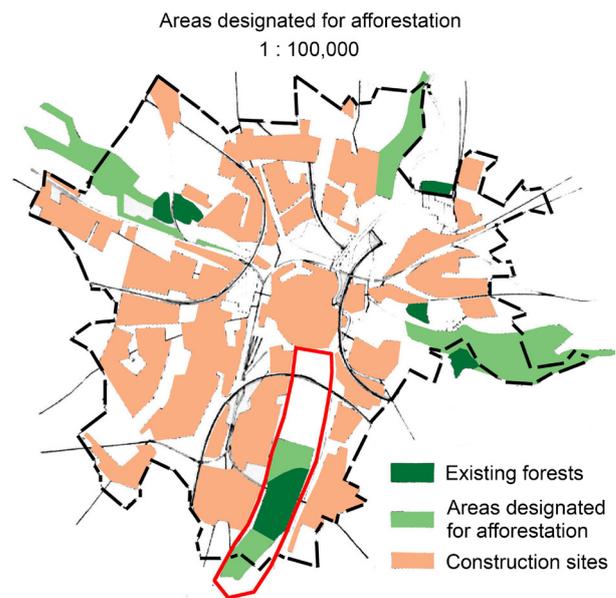
**Fig. 3.** Professor Adam Wodziczko's plan showing the forest in Dębina and the neighbouring areas designated for afforestation. The area discussed in this study is marked in red. (Source: compiled by B. Łukasik based on A. Wodziczko's plan)

Warta river, which borders the studied area, is the axis of the natural system of Wielkopolska region. The river forms an ecological corridor of national importance, and is an element of the EURONET PL European ecological network (Liszkowska et al. 2009). The concept of the "green wedge" – the green corridor system of Poznań, developed in 1932 by Władysław Czarnecki, took into account the existing greenery complexes (Kodym-Kozaczko and Kozaczko, 2014). The area of Łęgi Dębińskie and Dębina forests was located within the southern green wedge, located along the Warta river, and constituted the largest compact complex of existing greenery within Czarnecki's plan (see: Fig. 3).

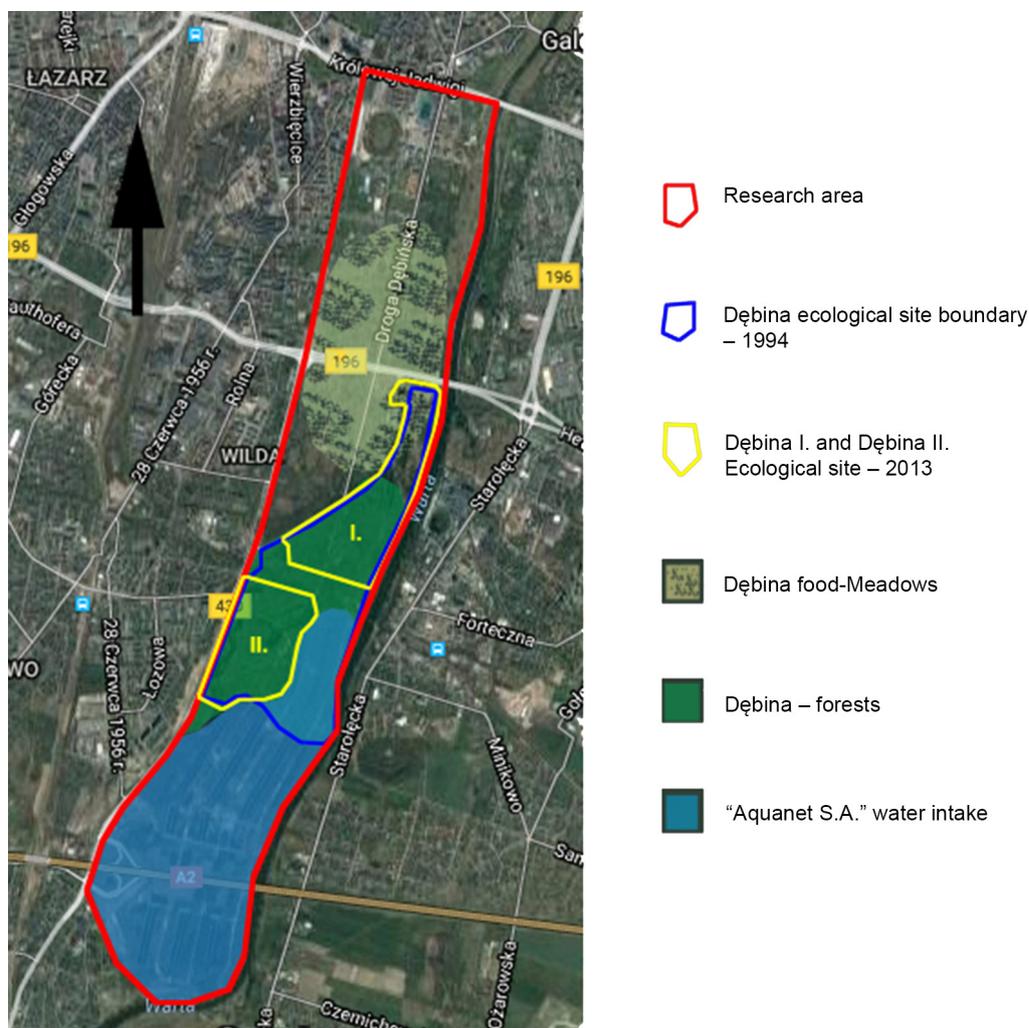
**Fig. 4.** A functional and spatial scheme of Dębina (Source: compiled by B. Łukasik)

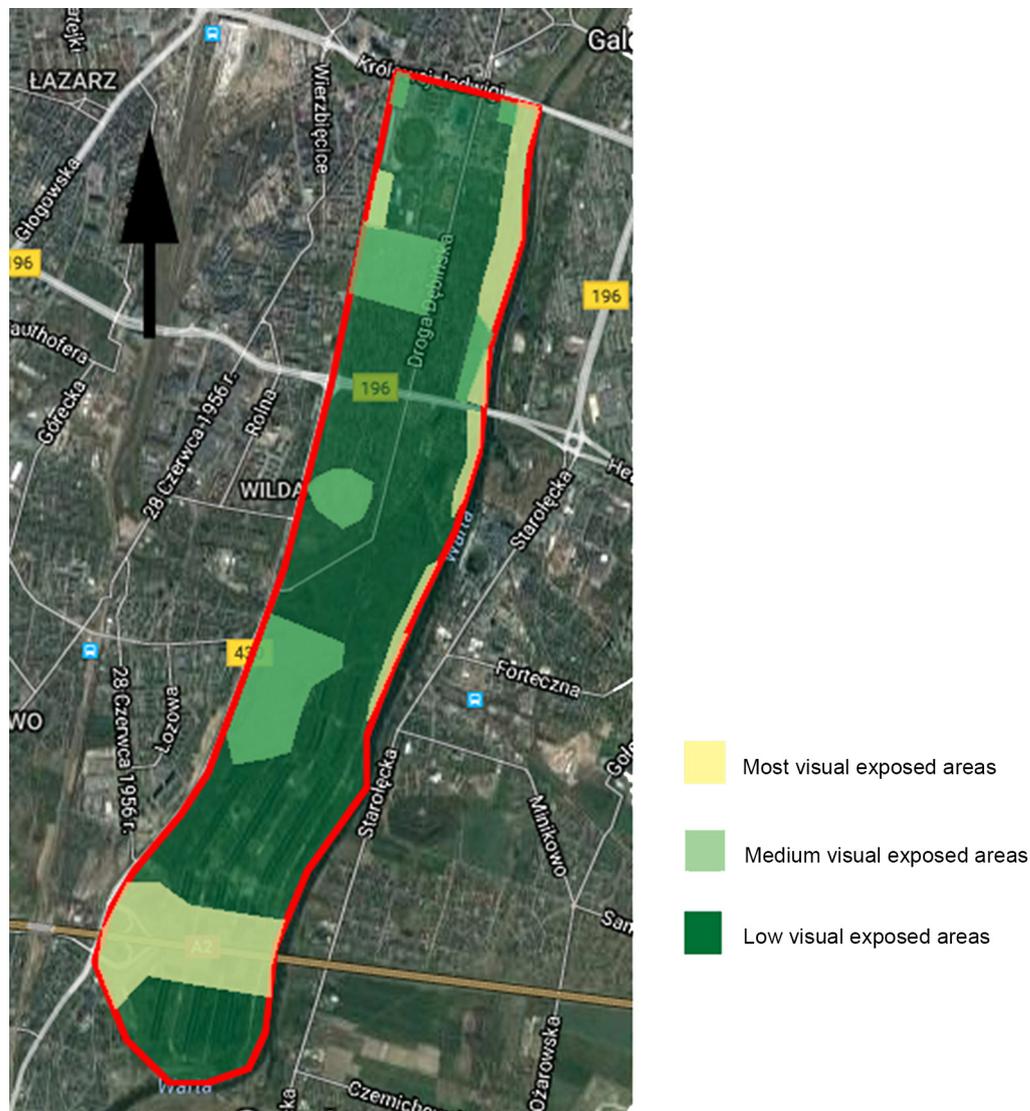
**Fig. 5.** Diversification of areas in terms of visibility (Source: compiled by B. Łukasik)

Currently, deciduous species of native origin dominate in the wooded area of Dębina. The picturesque quality of the trees is emphasized by grassy glades and four large ponds: Słoneczny, Dębowy, Borusa and Grundela, constituting the remains of the former Warta riverbed. The Warta river is an unquestionable landscape asset (although it is visible only from riverbank areas and from the bridges). Its waters form the foreground for the greenery and the urban development along the banks. The perception of vistas that feature Warta river, however, is small and limited to areas that are more easily accessible (see: Fig. 5).

From the highway bridge, apart from the river, the drinking water intake is visible along with rectangular infiltration ponds. Their regular outlines contrast against the naturally shaped greenery. From other sides, the area of the intake is virtually invisible, as are the complexes of family garden allotments (ROD) located in the northern part of the studied area. Currently, a significant share of high greenery and forests shelters large areas of Dębina from the view. The A2 motorway is a very aggressive element in the local

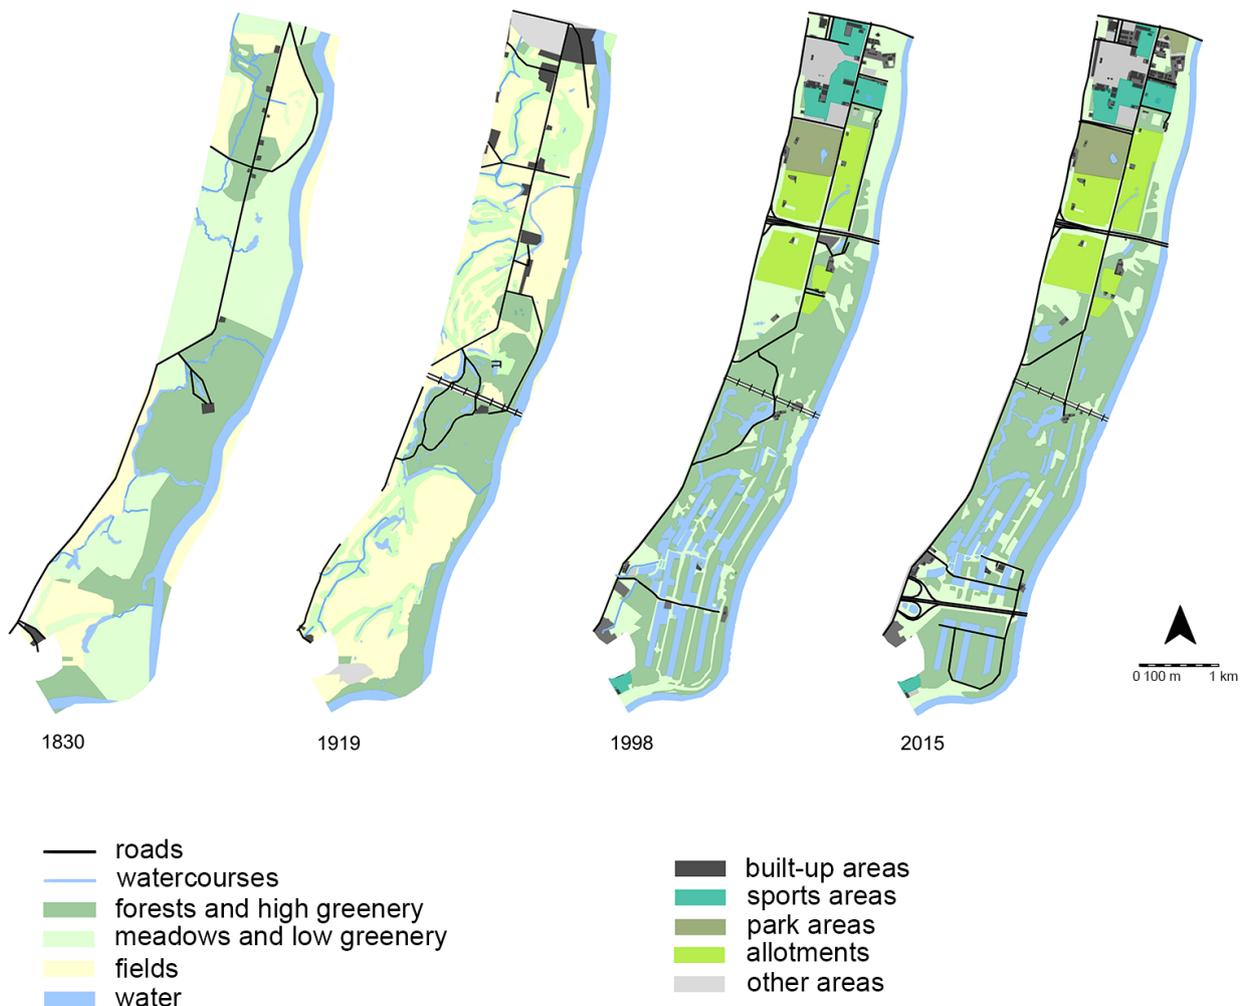
**Fig. 6.** The development of Dębina in different periods (Source: compiled by A. Wilkaniec)

At the beginning of the twentieth century, the largest area in Dębina was occupied by arable land (266.52 ha, 44% of the total area), which replaced meadows and forests. The share of built-up areas increased considerably (22.28 ha, 4% of the total area, increasing by

nearly 18.5 ha compared to 1830, that is, by 486.32%) (see: Fig. 6–7, Table 1).

dispersed. However, we should consider the fact that the buildings on the plots visible on the map from 1919 were not compact, and occupied a small area as opposed to large surface and cubic capacity of buildings constructed in the second half of the twentieth century. Also, the existing built-up areas in 1998 do not include individual development of allotment gardens and structures related to sports grounds (stadium, sports fields). The area of water reservoirs on Dębina increased (59.32 ha, i.e. 10% share, which constitutes an increase of 38.7 ha, that is by 187.68% in relation to 1919). This was undoubtedly related to the accumulation of ponds in recreational areas and the construction of reservoirs for the needs of water intake (see: Fig. 6–7, Table 1).

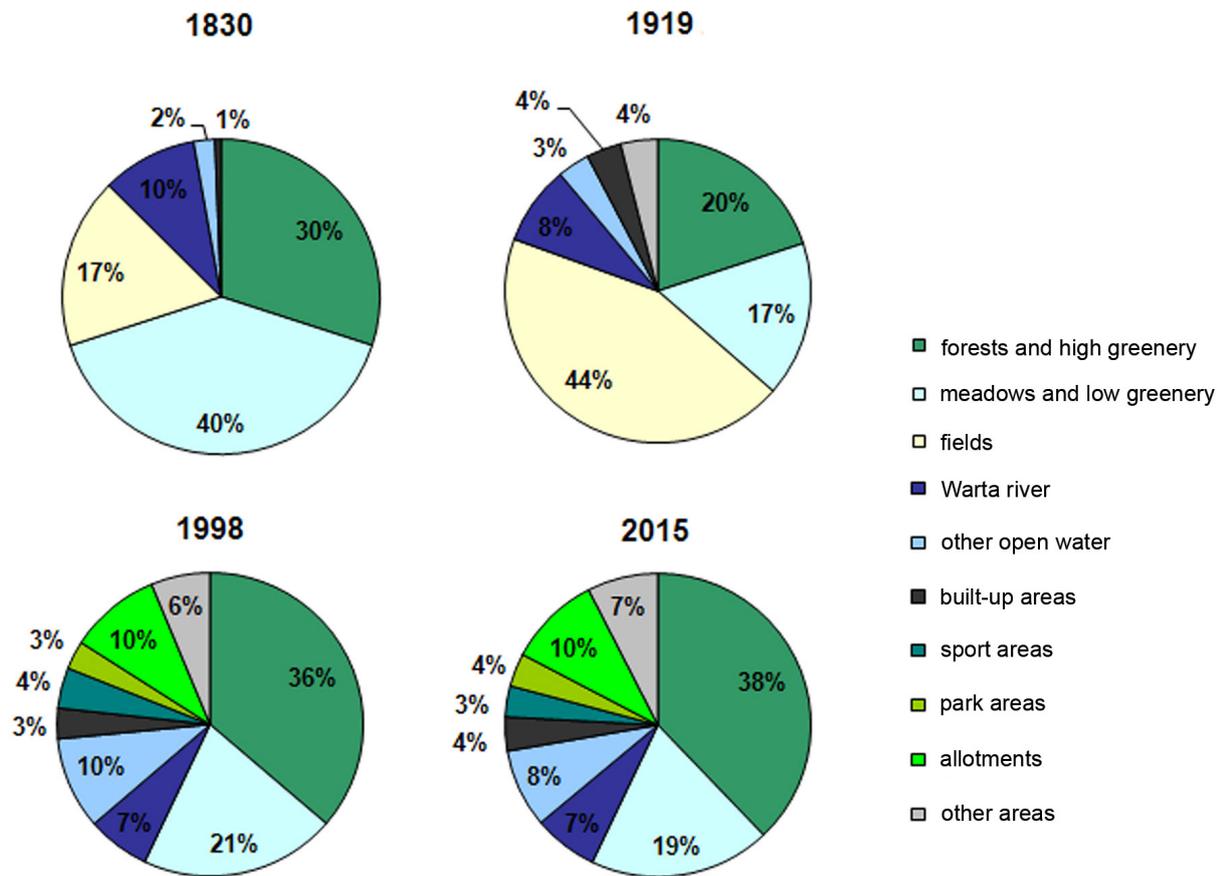
Fig. 7. The percentage share of areas with different types of development (Source: compiled by A. Wilkaniec)
